**INDONESIA: EARLY CHILDHOOD  
DEVELOPMENT PROJECT**

**CONSTRUCTION OF KINDERGARTENS &  
BKB/POSYANDU CENTRES**

**IMPLEMENTATION SPECIALIST'S REPORT  
MAY 2002**

MAY 2002

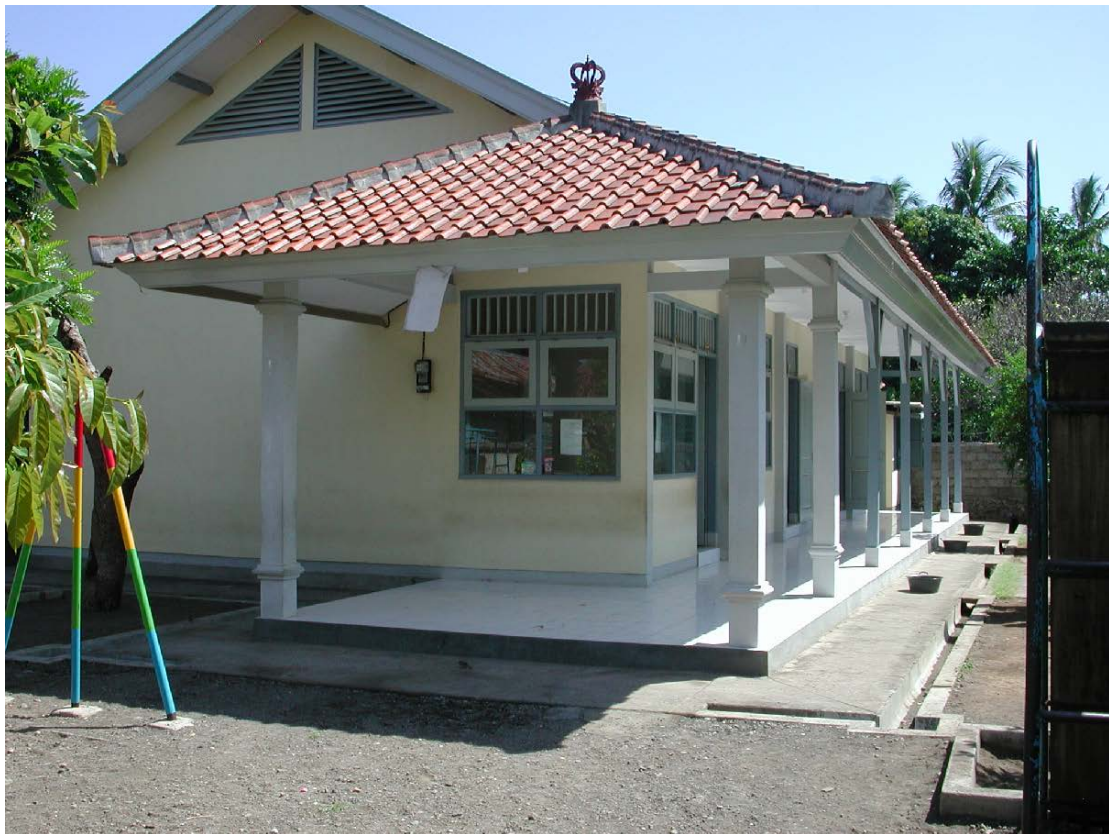
Plate 2: TK Eka Dharma, Jl. Pahlawan 8, Singaraja

There are 83 children in three classes (the large classroom has dividers and is used as two classrooms) and 5 teachers including the principal. The kindergarten has furniture and equipment from the old building with some new external play equipment. There was no problem with the site as it was an existing kindergarten.

The building was constructed during 2001 and took 5 months to build using local labour with a local supervisor. All floors including the verandas have been tiled with glazed ceramic tiles and the external ceilings have been sealed with ply panels. The large classroom has 4No 600mm fluorescent light fittings. The building is on the whole very well built, painted and finished but there are a few cracks in the walls and the panels in the hardwood doors have shrunk badly in most cases and should be replaced using seasoned timber. The ply panels to some ceilings also require re-fixing (they were nailed too close to the edges of the panels). The windows and window frames are nicely made and the toilets are neatly tiled.

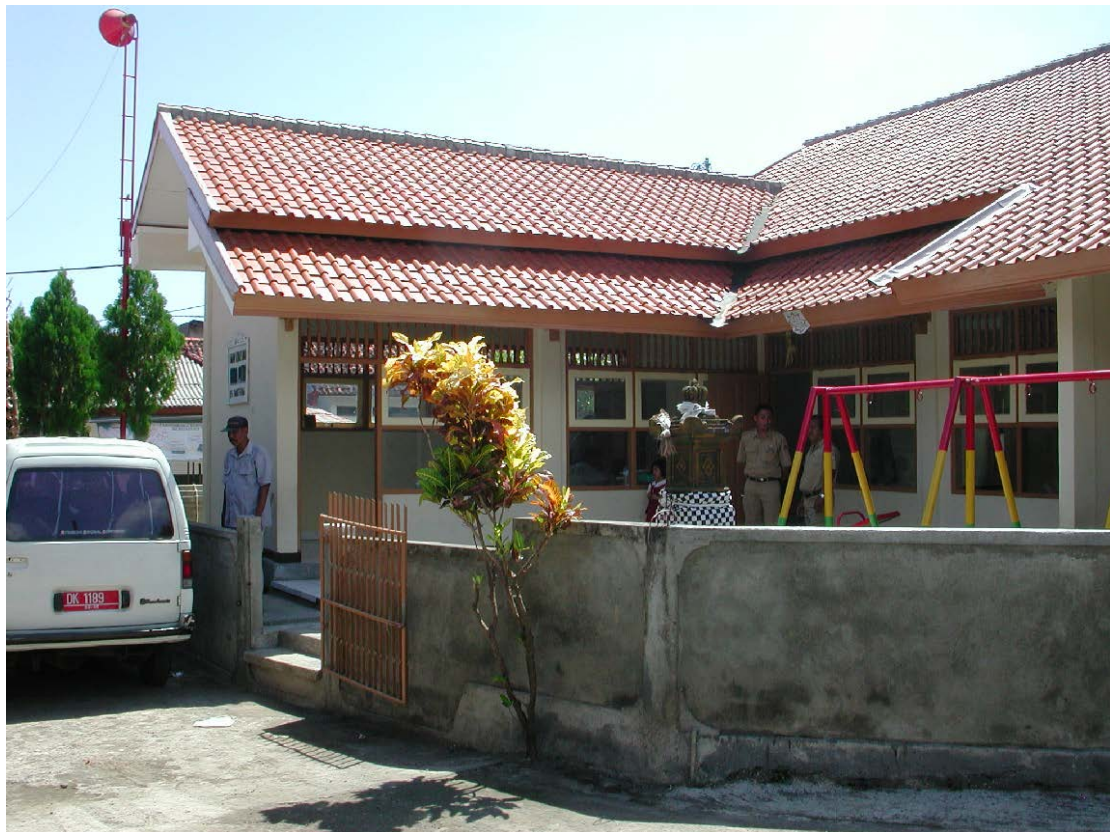
Plate 3: TK Bina Putra, Desa Bakti Srage, Kecamatan Bulaleng

Again it is classed as a renovation but the old building was demolished and a completely new building was constructed. The budget was again only Rp96

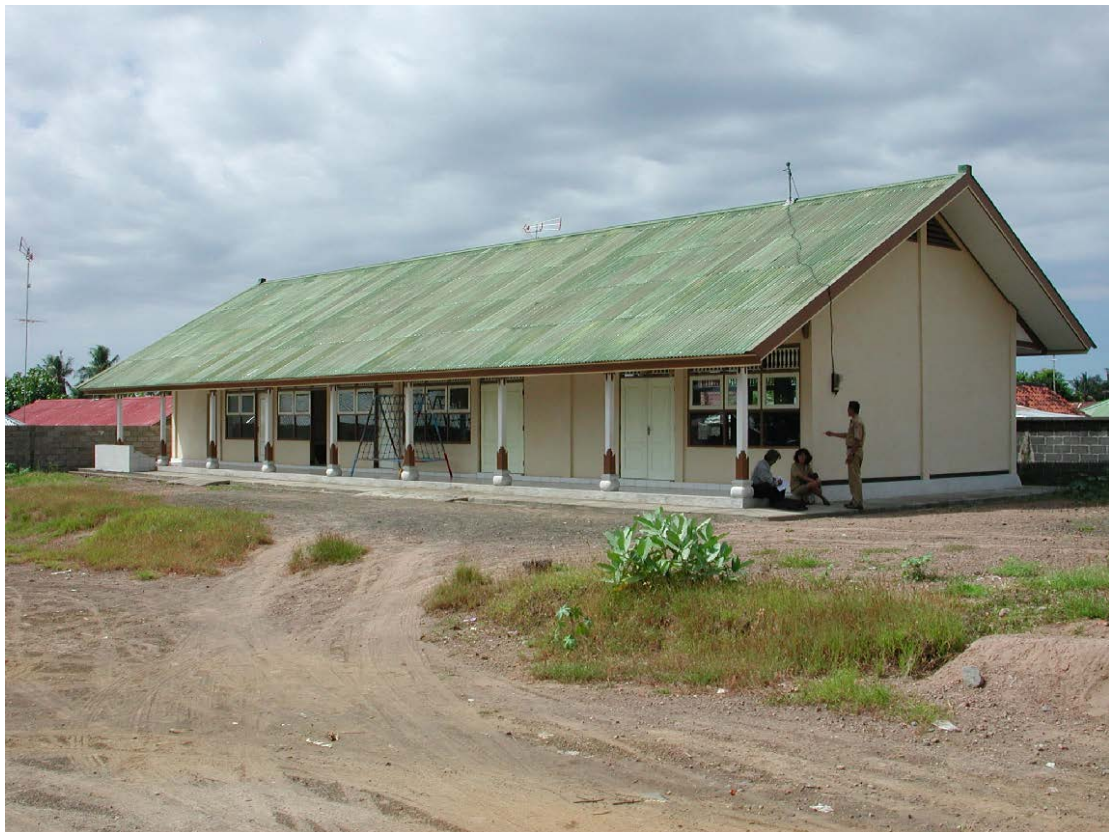
Plate 5: TK Bung Kulan, Kecamatan Sawon

been sealed with ply panels. The veranda has RC columns and the roof is of corrugated steel sheets which have been painted (not very well; are the roof sheets and the paint to the correct specifications?). The large classroom has 8 tungsten light fittings. The building is on the whole well built but there are some cracks to walls, some door panels are shrinking and the painting to the doors is not very good. The tiling to the floors is also a little uneven. One major problem is that a section of drain at the rear of the building has collapsed and the paving has been undermined. This has probably been caused by the soakaway subsiding and should be rectified as soon as possible. The building has one metre wide paving and a storm drain all round. There is no wall at the front of the site as the budget was not sufficient. It is hoped that funds for the wall will be found this year.

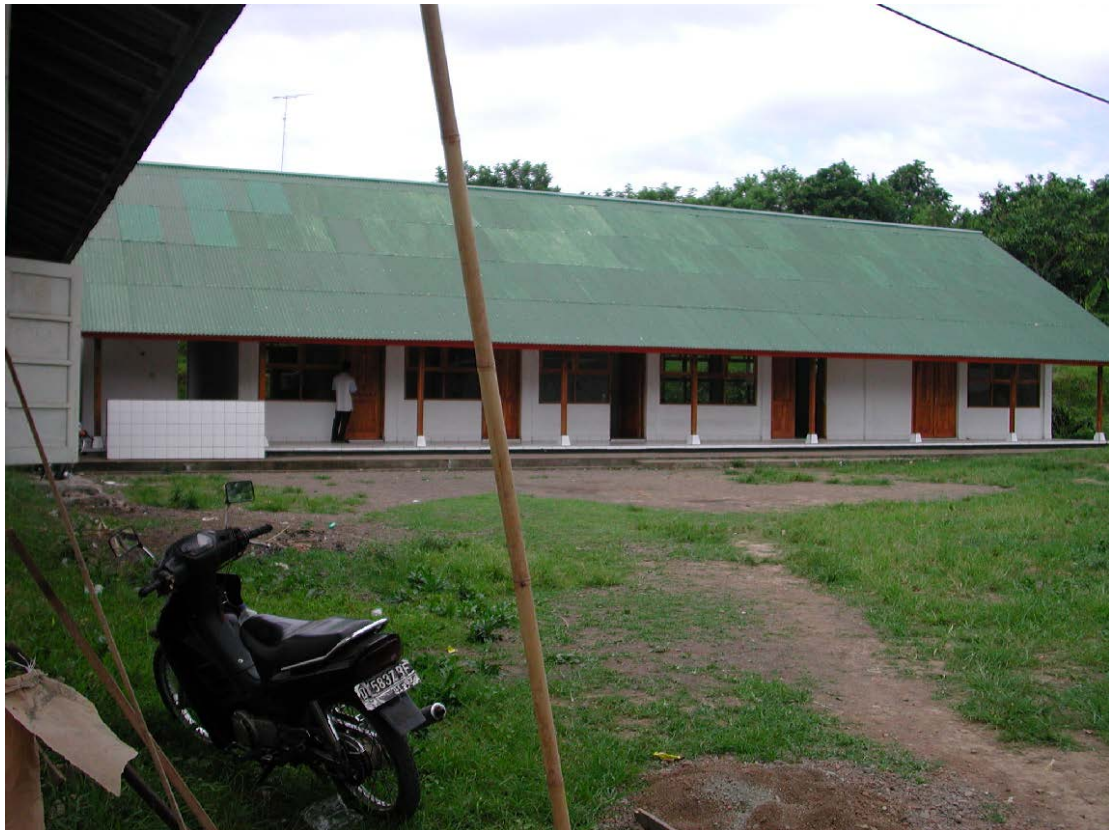
Plate 6: TK Desa Bila, Kecamatan Kubutambahan

Construction of the buildings started in August and was finished in October 2001 using local labour with a local supervisor. There were approximately 20 workers on site during construction. The supervisor received Rp40,000 a day, the foreman Rp35,000 a day, skilled workers Rp25,000/27,500 a day, and labourers between Rp12,500/15,000 a day. The CS visited twice a week and was very useful. He prepared a very basic site layout to scale 1:200. All floors including the verandas have been tiled with glazed ceramic tiles which were part of the community contribution. The community also donated bamboo panels for the ceilings to the veranda, the rooms and the external ceilings. The veranda has timber columns and the roof is of corrugated steel sheets which have been painted. The large classroom has 8 tungsten light fittings. The building is on the whole well built but the doors and windows (which are varnished) are not very well made or finished, the tiling to the floors is a little uneven and is not square laid, the

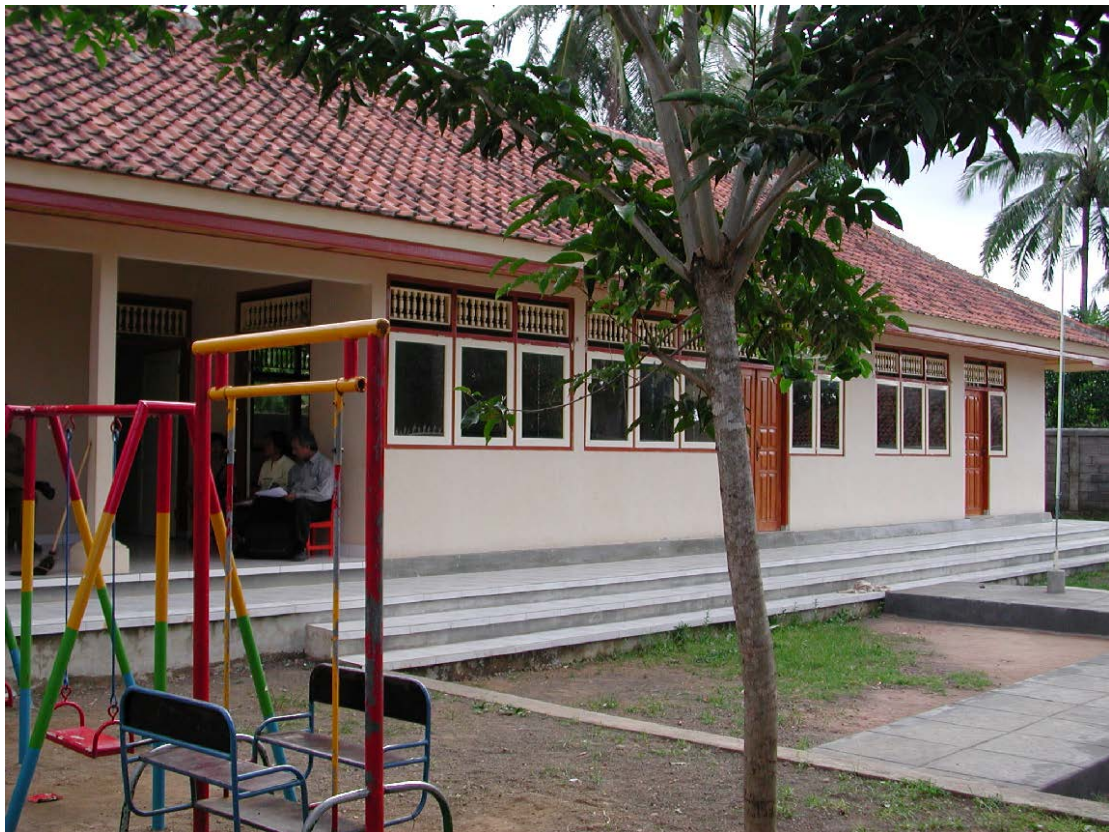
Plate 7: TK Bina Putra Tamblang, Kecamatan Kubu Tambahan

Construction was started in February and completed in July 2001 using local labour with a local supervisor. Only the walls of the existing part of the building were retained. The floors, windows, doors and roof are all new. All floors including the veranda (which is very narrow and also has three steps) have been tiled with glazed ceramic tiles and the external and internal ceilings have been sealed with very nicely finished bamboo panels. All rooms have one tungsten light fitting. The building is on the whole well built, painted and finished but there are some cracks in the walls. The windows, doors and frames are well made and finished and the tiling is well done. The wall to the front and one side is new and there is a new sliding steel gate. The very narrow tiled, front veranda and steps will be dangerous to the children and teachers when wet.

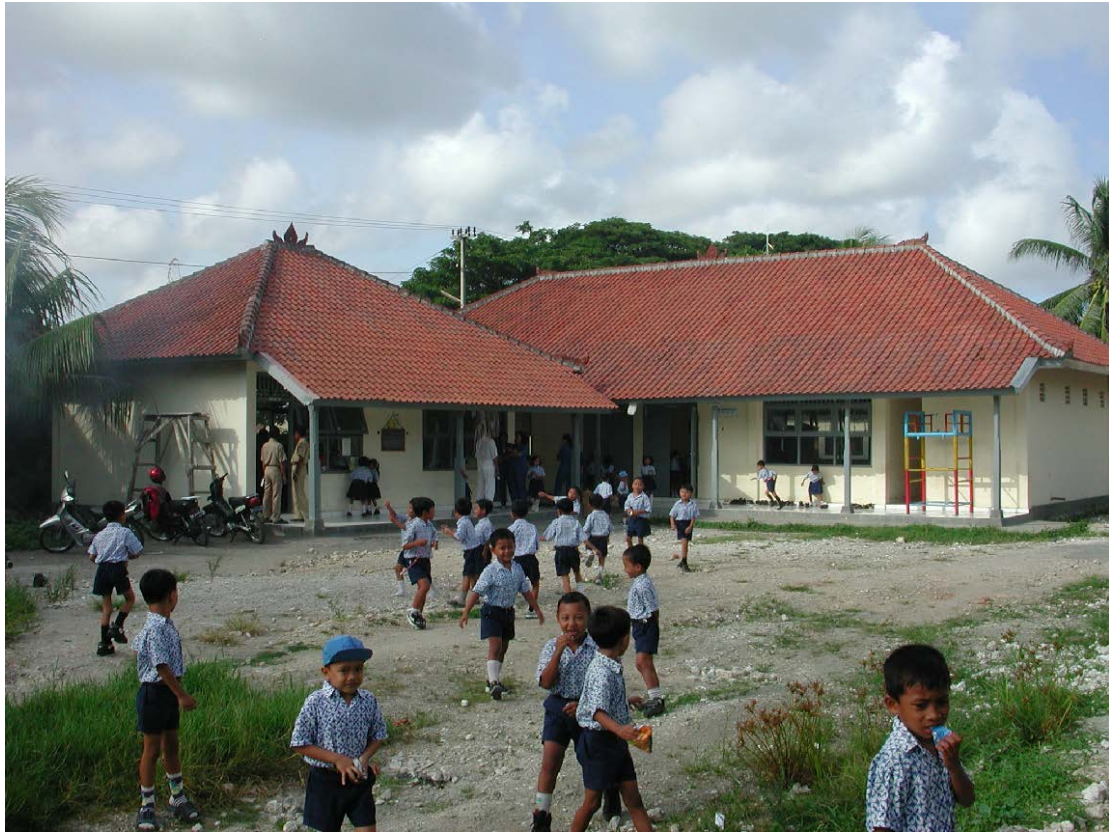
Plate 13: TK Kumara Sari 7, Desa Padang Sambian Klod, Denpasar Barat

The building has a tiled roof and timber and RC veranda columns. All floors including the verandas have been tiled with glazed ceramic tiles and the ceiling to the veranda only has been sealed with ply panels. The building is quite well built but the joinery and painting are not very well finished. Some ceiling panels are coming down and the ceilings require another coat of paint. There is also a leak to the roof over one veranda. The paving and drains to the classroom wing are not complete at the rear and there are none to the office wing. The site has been filled with limestone but still requires levelling.

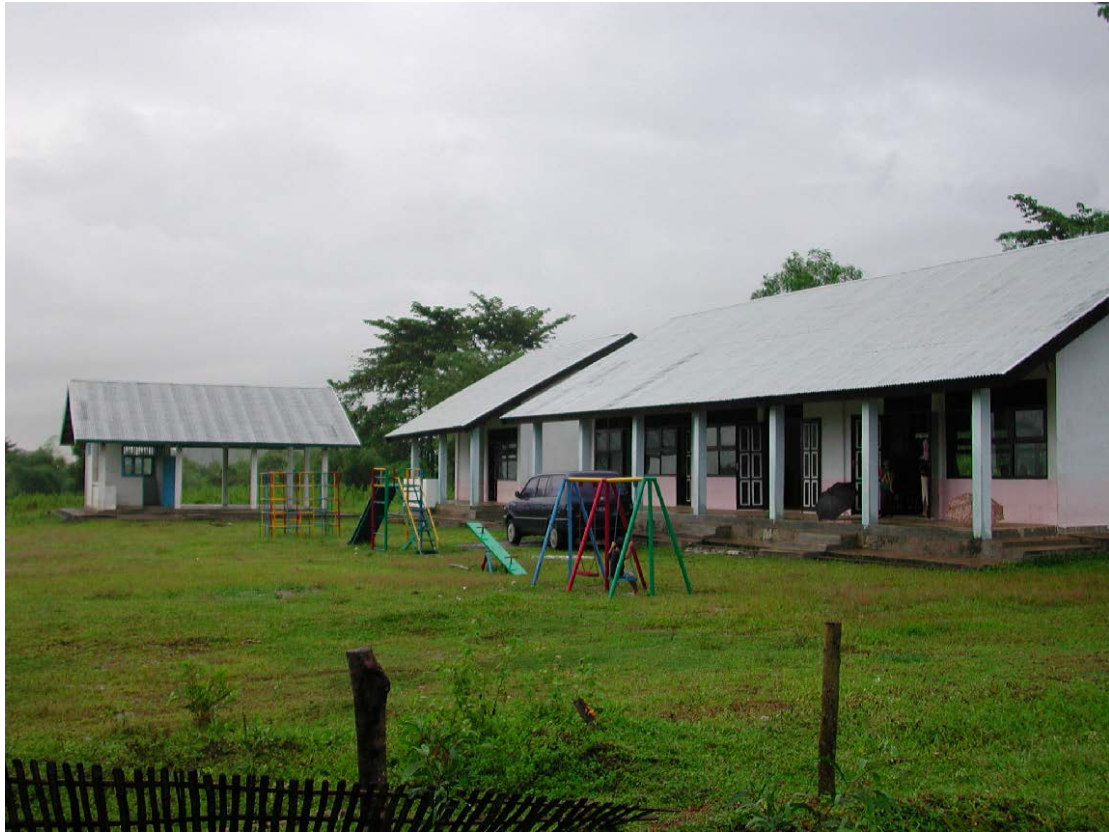
Plate 3: TK Harapan Bangsa, Belapun Ranga, Kecamatan Parang Loe

coat of paint. The floors are however neatly tiled although the tiles require cleaning and the RC columns and roof timbers are good.

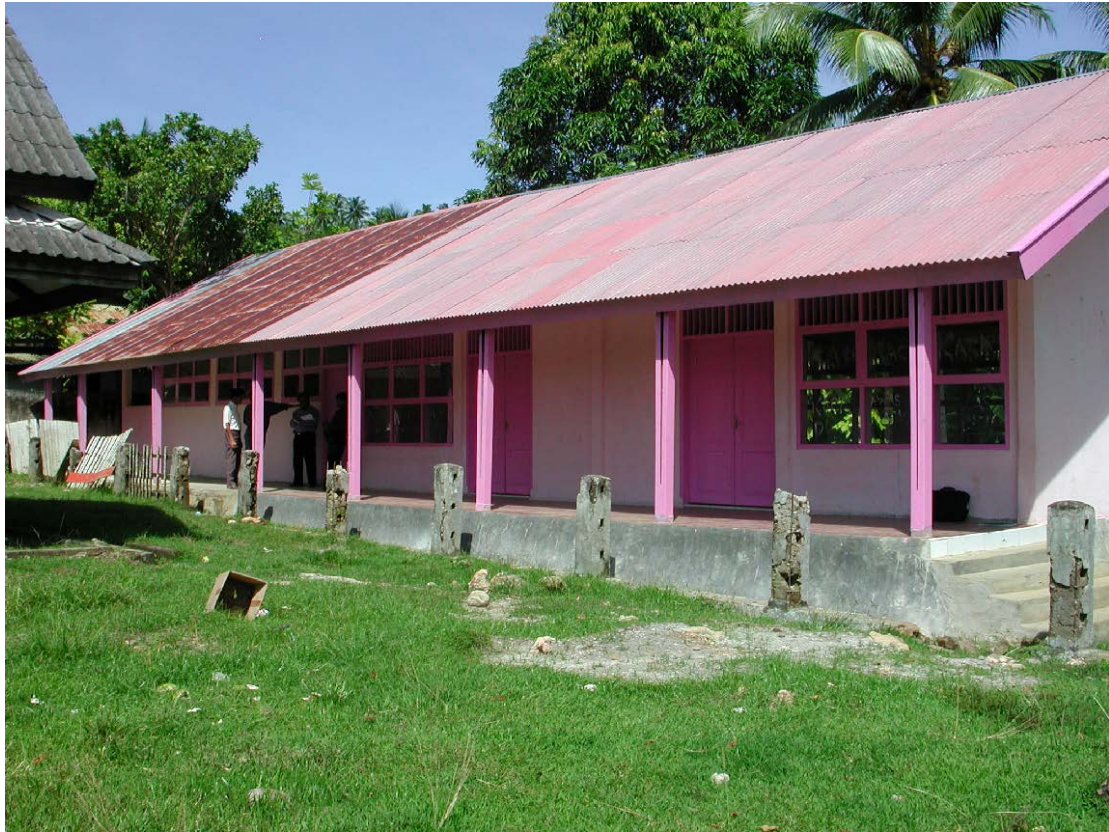
Plate 6: TK Pertiwi Tanah Jaya, Tanah Jaya, Kecamatan Kajang

The building has a (badly) painted corrugated steel roof on timber trusses and purlins, fibre-cement ceiling panels and timber windows and doors. All floors including the verandas have been tiled with glazed ceramic tiles and the external ceilings are sealed with fibre-cement sheets. The veranda has timber columns. The building is quite well built but the rendering and joinery are not very well finished (the windows are different in the old classroom) and the internal and external ceilings and walls all require at least one further coat of paint. The large classroom has six 600mm fluorescent lights but the electrical installation overall is badly wired and sub-standard.
