**SCHOOL IMPROVEMENT GRANT PROGRAMME 2  
VISITS TO PACITAN & PANDEGLANG DISTRICTS**

**SCHOOL REHABILITATION CONSULTANT'S REPORT  
JUNE 2003**

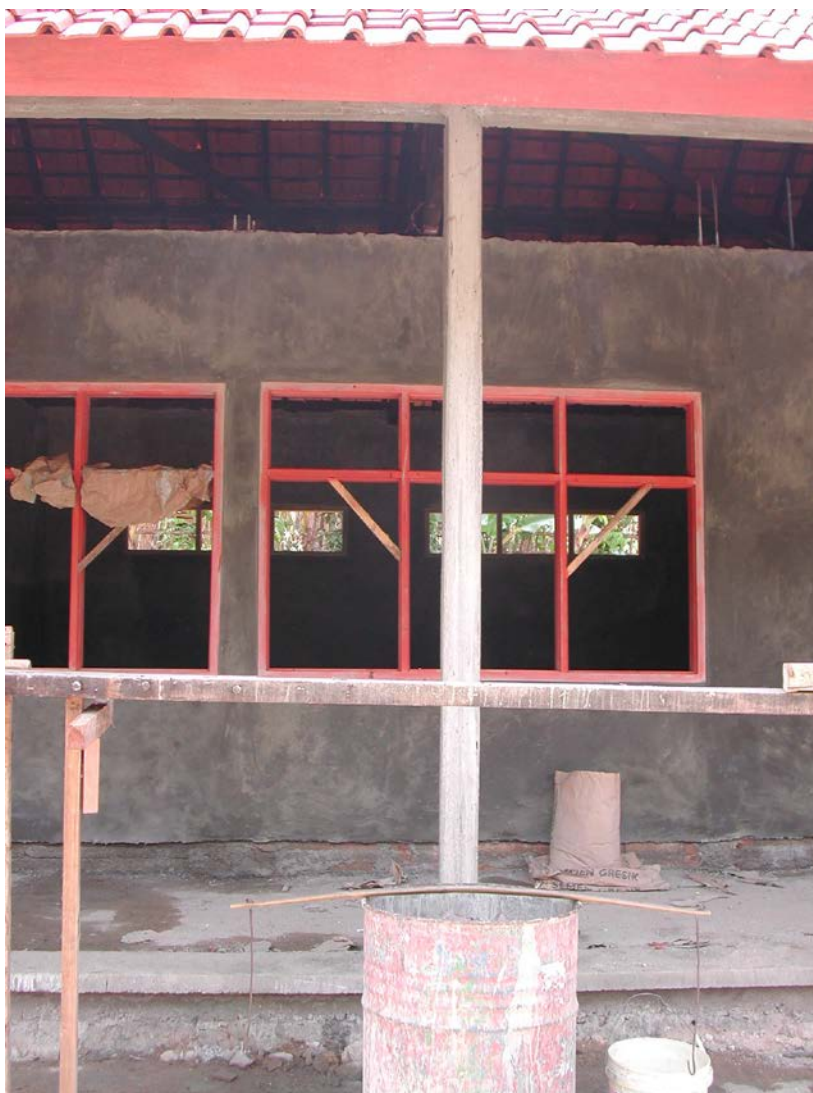
8.3 Size and position of concrete columns: At one school (SDN Gendaran) the size of the freestanding columns to the veranda seems inadequate (15 x 15cm) for the height of the columns and the loads being taken. At this school and at others the position of columns is unsound in that columns do not line up, beams do not occur on column lines, roof trusses do not occur over columns, etc.

Plate 1: SDN Gendaran 01 showing inadequate column sizes, lack of intermediate columns to classroom wall and trusses over the centre of windows

The new building is constructed of rendered brick walls, RC columns and beams, timber roof trusses, clay tiled roof, timber windows and panel doors. The trusses are good, made of good quality timber and the joinery and concrete are quite good but the structure of the new building is probably inadequate. The veranda columns are only 15 x 15cm and very high. The only visible RC columns in the classroom walls are at the cross walls and these are 15 x 20cm. If there are columns in between, they are only the thickness of the walls and they are not under the roof trusses; trusses are instead positioned over windows. The reinforcement to the columns to the toilets and the 'practical' columns to the classrooms is only 6.5mm with 3.5mm links at 25cm centres and is thus inadequate. There is some 8mm reinforcement on site and this was probably used for the main columns to the classrooms and verandas. This size is still however inadequate; it should have been 10mm or preferably 12mm. The consultants should check the structure as soon as possible and make proposals for strengthening it if necessary.

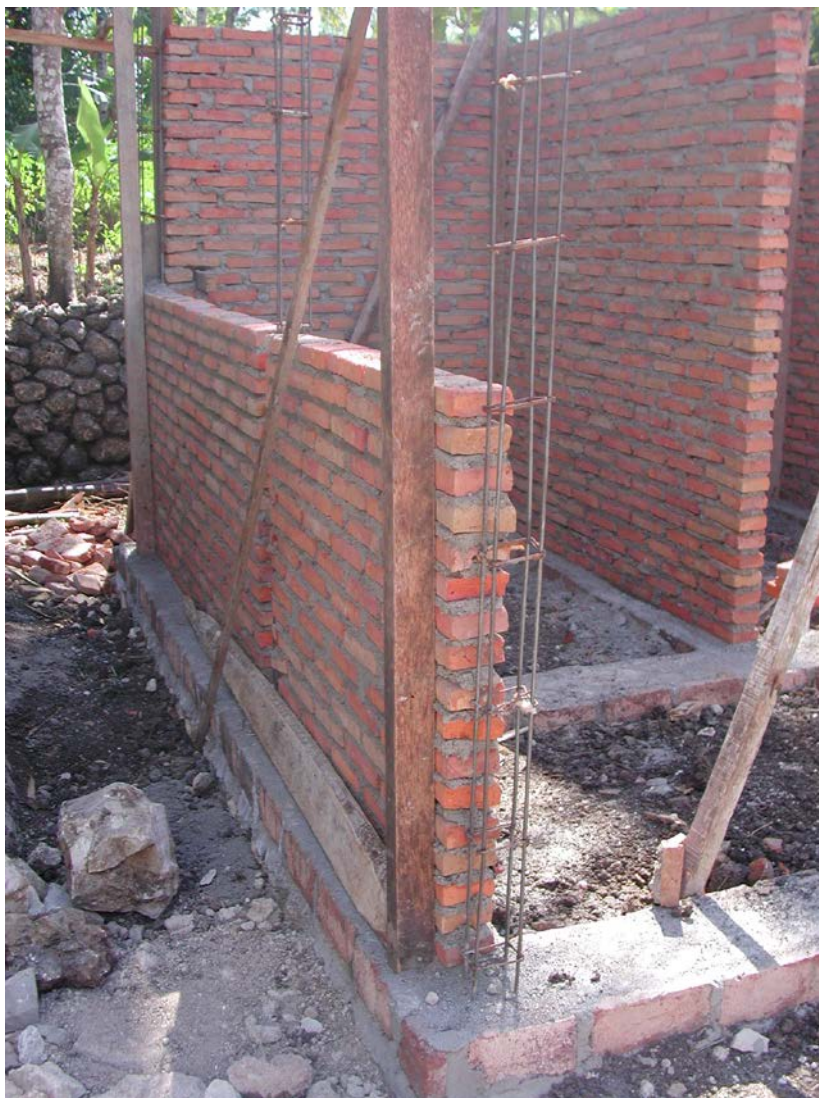
Plate 2: SDN Gendaran 01 showing inadequate column sizes to toilets

The proposals were prepared by the school committee and the drawings were prepared by a teacher who has built his own house. The drawings are very basic and the plans are different to what has been built. The columns are in different positions and are different sizes to those specified (20 x 20cm).

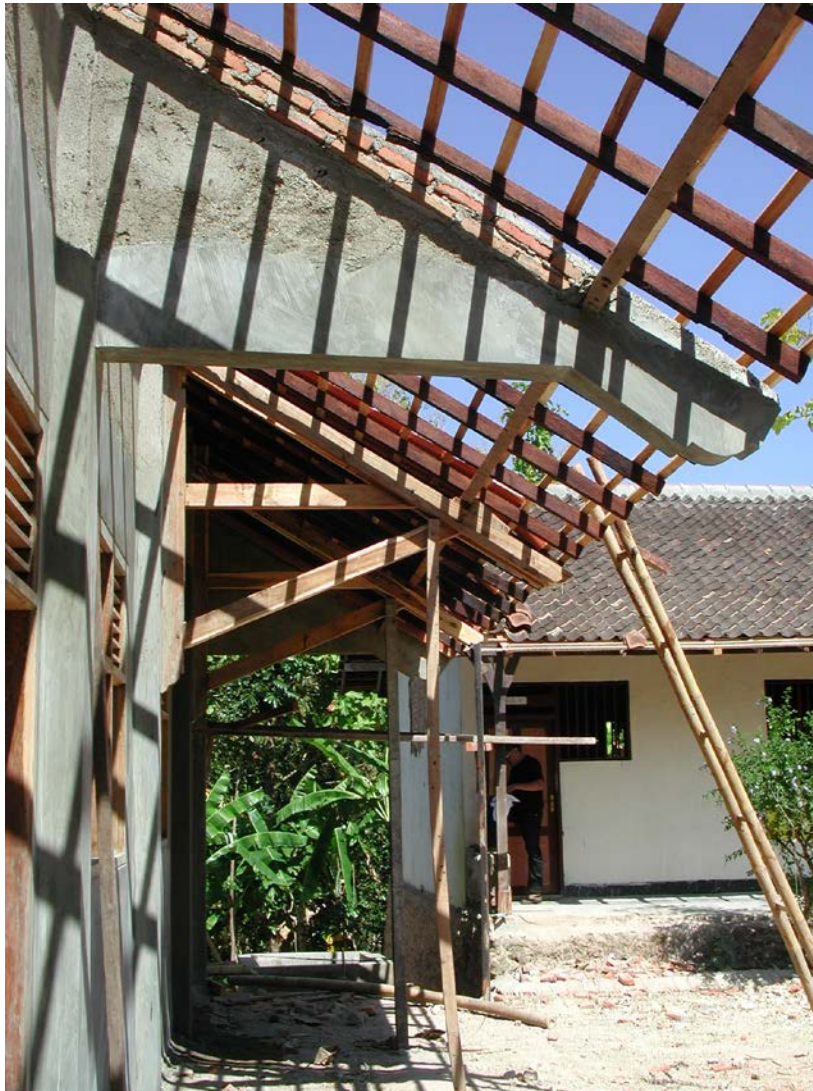
reinforcement to columns where it could be seen is only 8mm. There are concrete cantilevers supporting the veranda roof at the end and cross walls and the reinforcement to these is probably 8mm. The reinforcement to all columns and beams should have been a minimum of 10mm and preferably 12mm. Again the consultants should check the structure as soon as possible and make proposals for strengthening it if necessary.

Plate 3: SDN Sendang 3 showing large concrete cantilevers, the structure of which should be checked

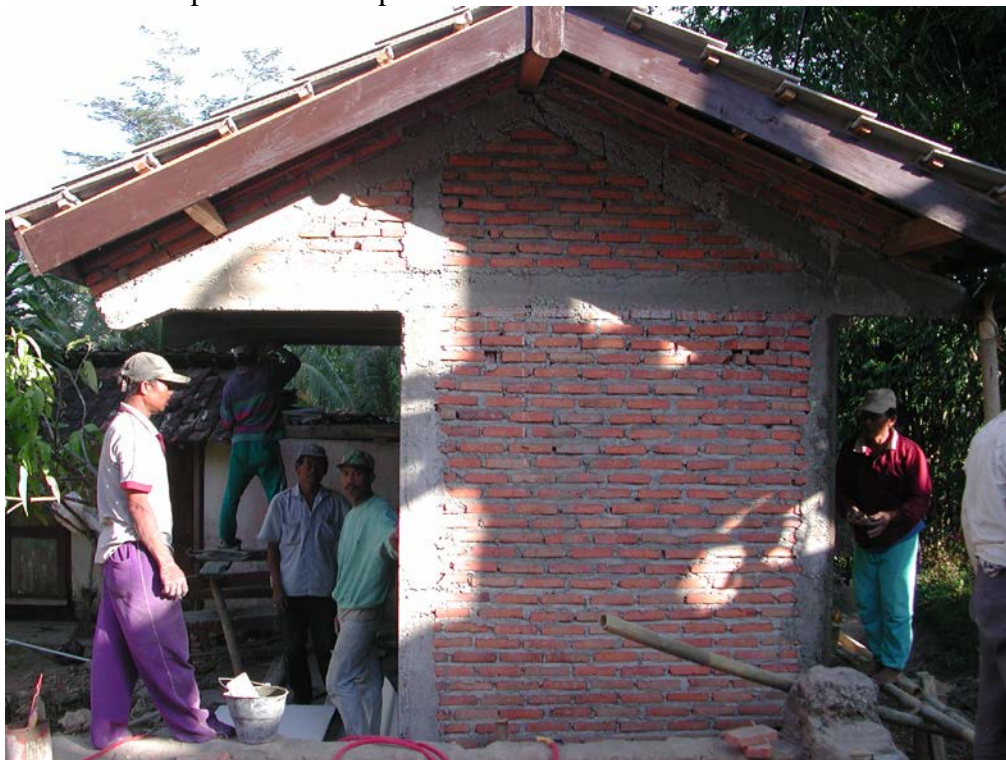
Plate 4: SDN Gungganggan 02 showing cantilevered roof to toilets with only 6mm reinforcement

The SCA again seems to have had very little input. He did not help with the preparation of drawings or of the bills of quantities or schedules of materials. No comments have been made on any of the construction and he does not appear to have picked up the fact that the reinforcement especially to the toilets is inadequate.

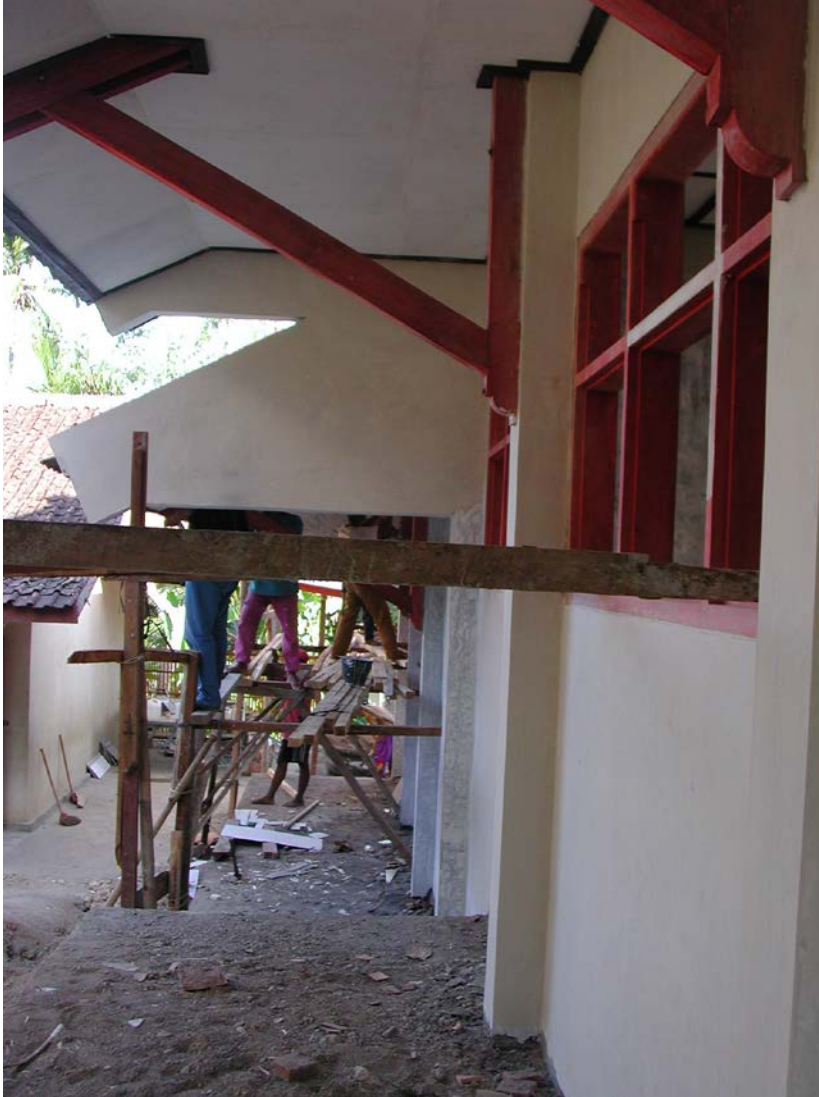
Plate 5: SDN Gungangan 02 showing large concrete cantilevers, the structure of which should be checked

The new building is constructed of rendered brick walls, RC columns and beams, concrete tile floors, timber roof trusses, clay tiled roof, cantilevered roof over the veranda, timber windows and panel doors. The building seems to be well constructed although it was not possible to see the roof trusses or the concrete columns as ceilings had been fixed and the columns were rendered. The joinery is quite good as are the timber cantilever brackets. The reinforcement to the columns in the classrooms is 9mm but the reinforcement to the beams, cantilever beams and columns to the toilets is only 6mm and the quality of the concrete is very poor. The reinforcement to all columns and beams should have been a minimum of 10mm and preferably 12mm.

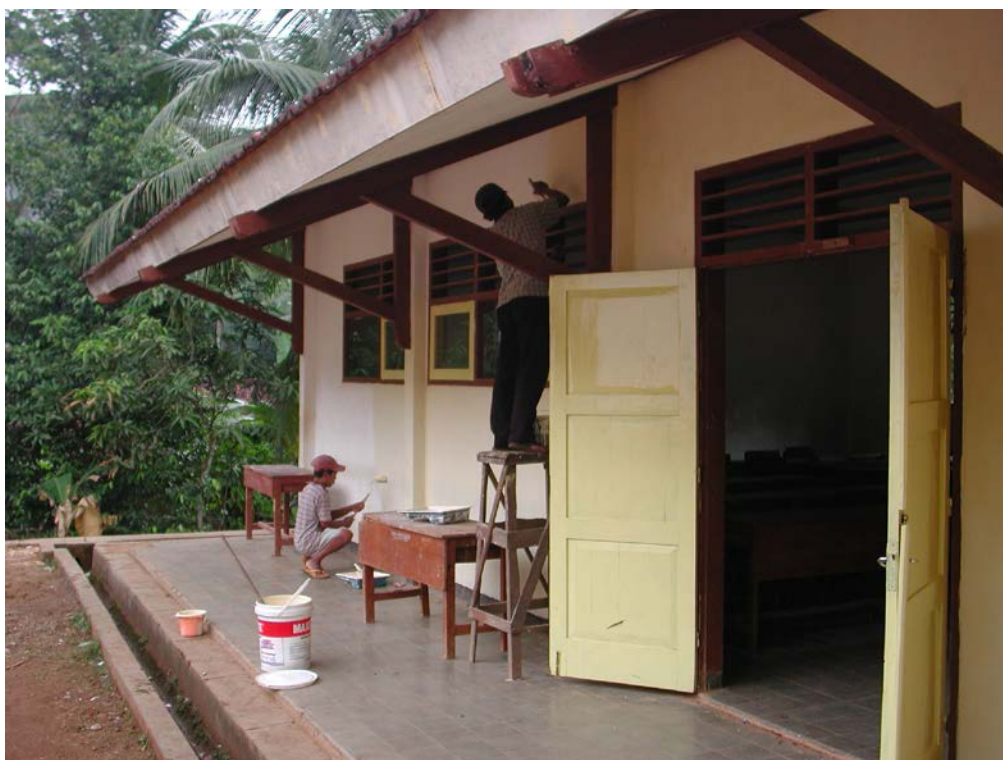
Plate 6: SLTPN Tegalombo showing renovations in progress

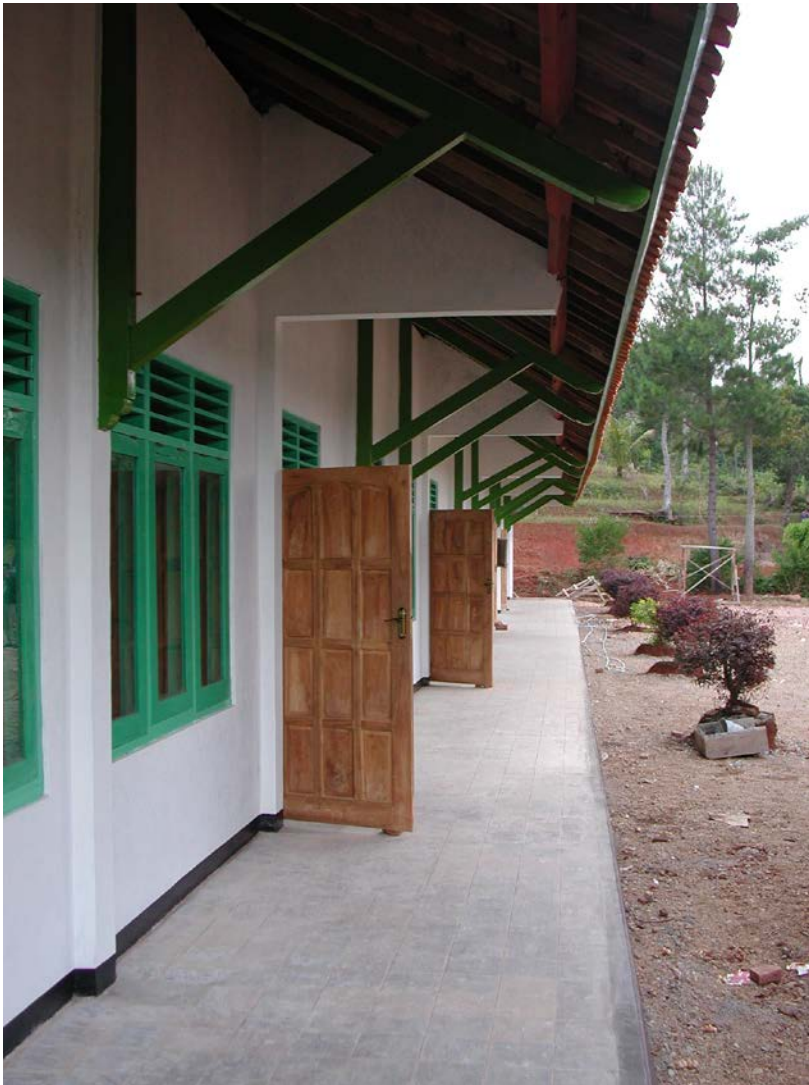
Plate 7: SDN Tahinan 5 showing concrete cantilevered beams the structure of which should be checked

The building is constructed of rendered brick walls, RC columns and beams, timber roof trusses, clay tiled roof, cantilevered roof over the veranda, concrete tiled veranda floors, timber windows and panel doors. There are not many opening windows in the office and adjoining classroom. The building is quite well constructed: the roof trusses are well made and the windows and doors are quite good. The painting however is not very good and the roof, especially at the rear is not very level (there are only three purlins per side). It was not possible to see the columns as they had been rendered but the reinforcement appeared to be 8mm. There are no ceilings but the school site is high up in the mountains and the school is quite cool. The consultants should check the structure to see if it is adequate and if not, make proposals for strengthening it.

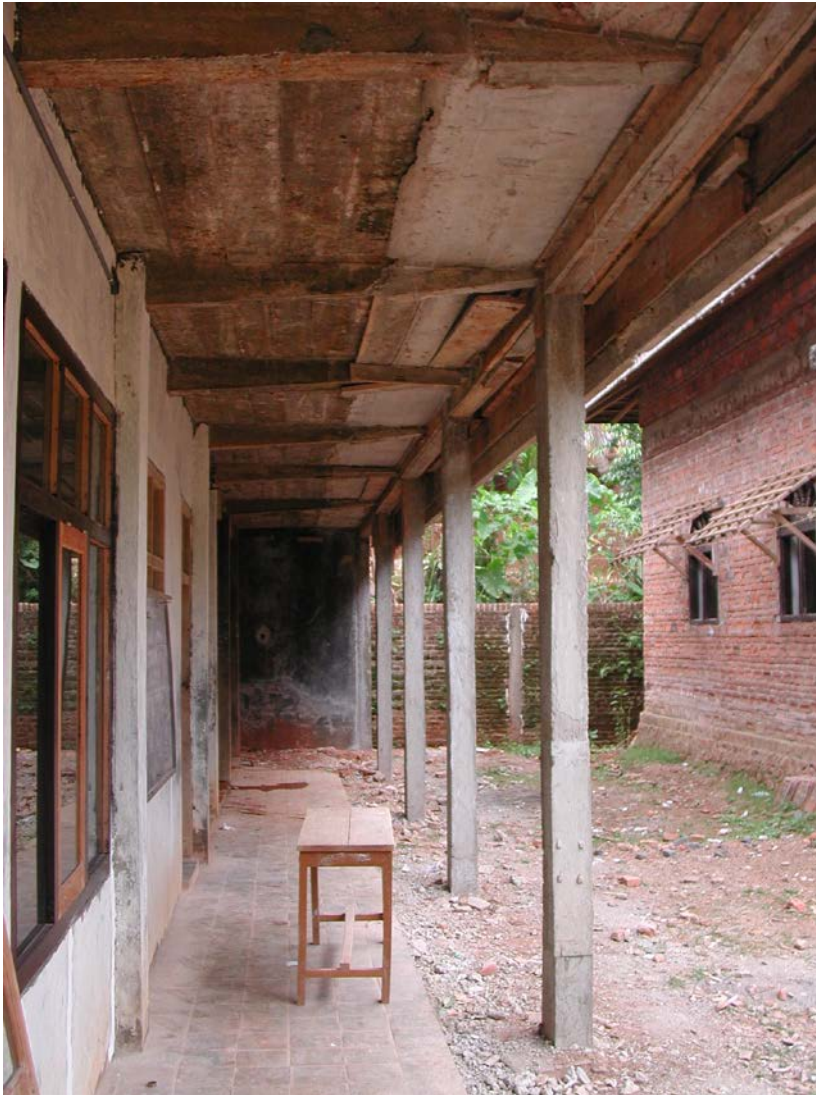
8.4 Structural safety: At one school (Al-Fatah MTs) the safety of the school structure as built is very questionable. Under the SIGP programme an additional storey has been constructed on an existing single-storey building and it is the structure of the existing building that is questionable. The structural design and the size of the reinforcement (8mm) seems to be inadequate, the actual quality of construction leaves much to be desired and the first floor balcony has been extended in a way that is structurally unsound.

The SCA in this case should have refused to accept the school committee's proposal and should have asked for advice from the CC. It should be noted that there is another two-storey building on this site that is in an even more dangerous condition.

Plate 8: MTs Al-Fatah showing inadequate ground floor structure

The SCA made five visits but seems to have made no technical comments or recommendations. He did not help with the preparation of drawings, budgets or schedules of materials. The SCA should in this case have told the school committee that the ground floor of the building was probably unsafe and that they should not construct a first floor on top. If they did not agree to his recommendation then he should have informed the CC. This school is in an earthquake area and the

consultants should check the structure of this building as soon as possible to see if it is safe and if it is not, make proposals for strengthening it.

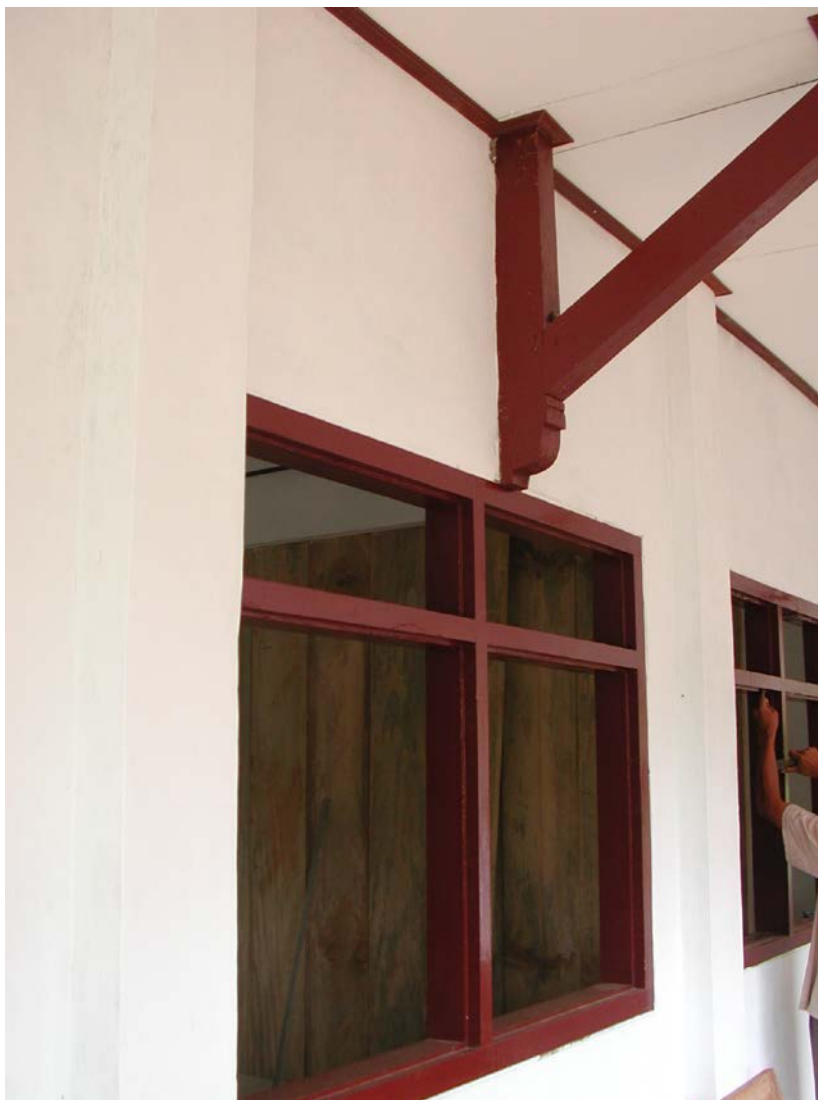
Plate 9: MTs Al-Fatah showing new roof trusses over windows

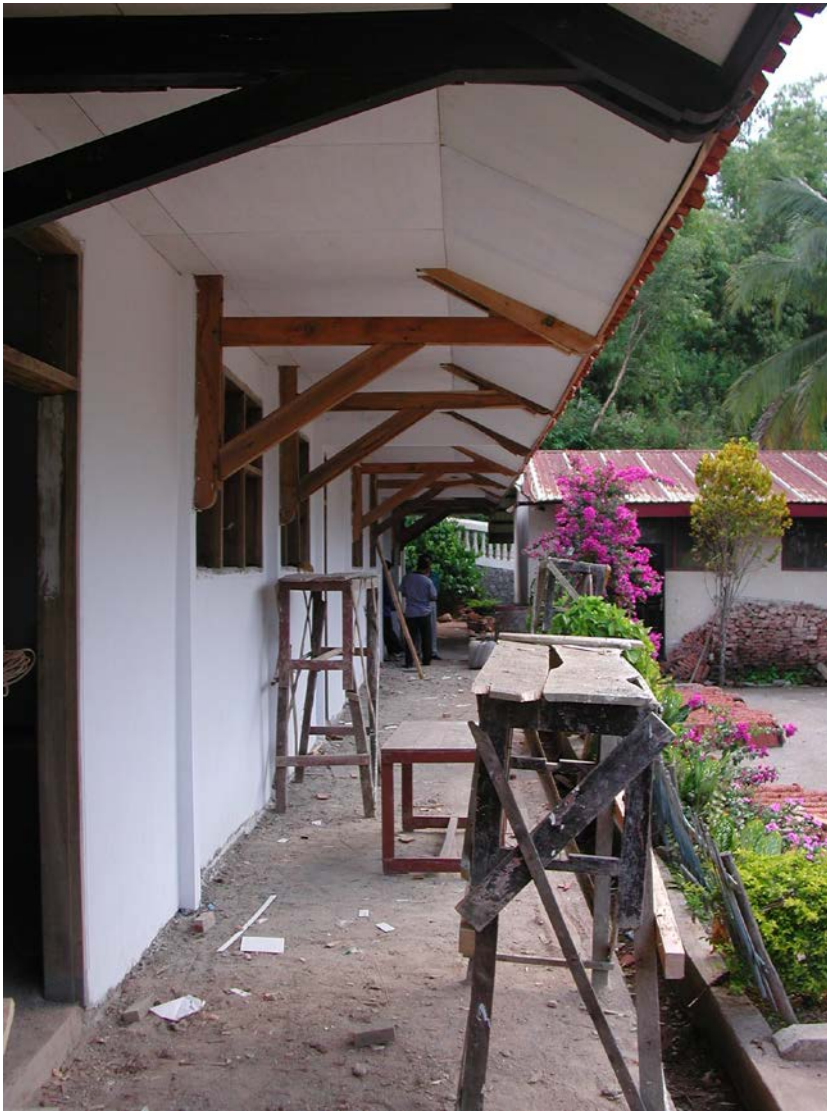
Plate 10: SDN Ploso 2 showing new building

The new building is constructed of rendered brick walls, RC columns, timber roof trusses, clay tiled roof, cantilevered timber roof over the veranda, white-glazed tiled floors to two classrooms and existing concrete tiles to the third classroom and veranda floors, timber windows and panel doors. The building is quite well constructed: the roof trusses could not be seen but the roof is straight, the roof cantilevers are well made and the windows and are quite good. It was not possible to see the columns as they had been rendered but the only reinforcement seen on site was 6mm and 4mm.

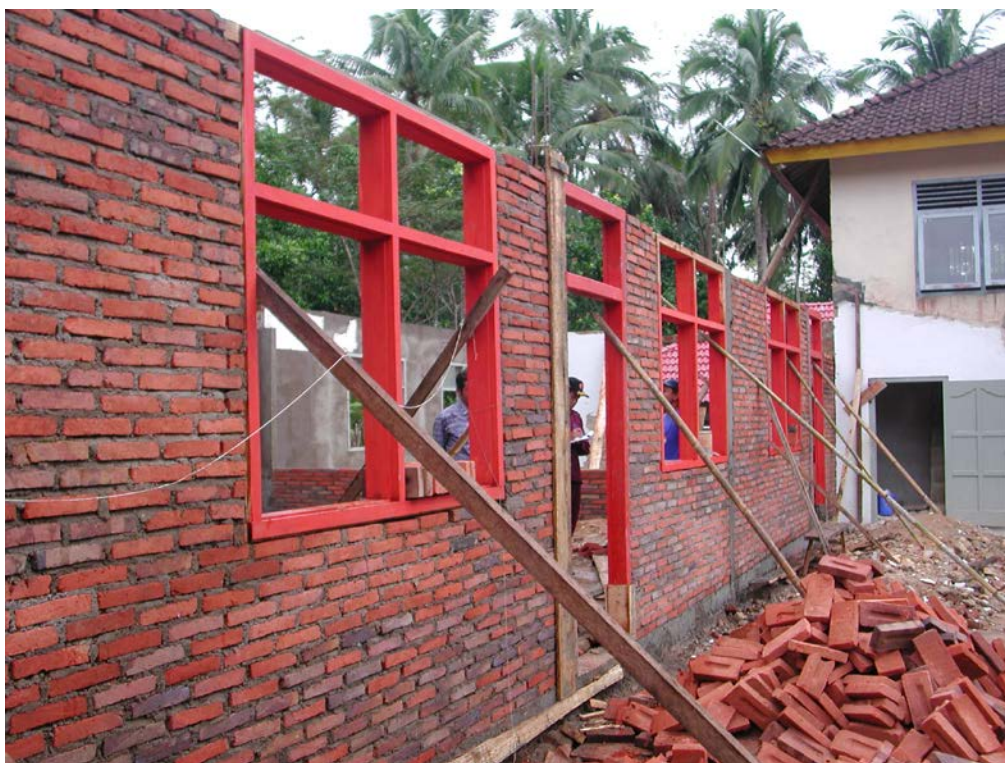
Plate 11: MTs Muhammadiyah 3 Ketro showing work in progress on classrooms

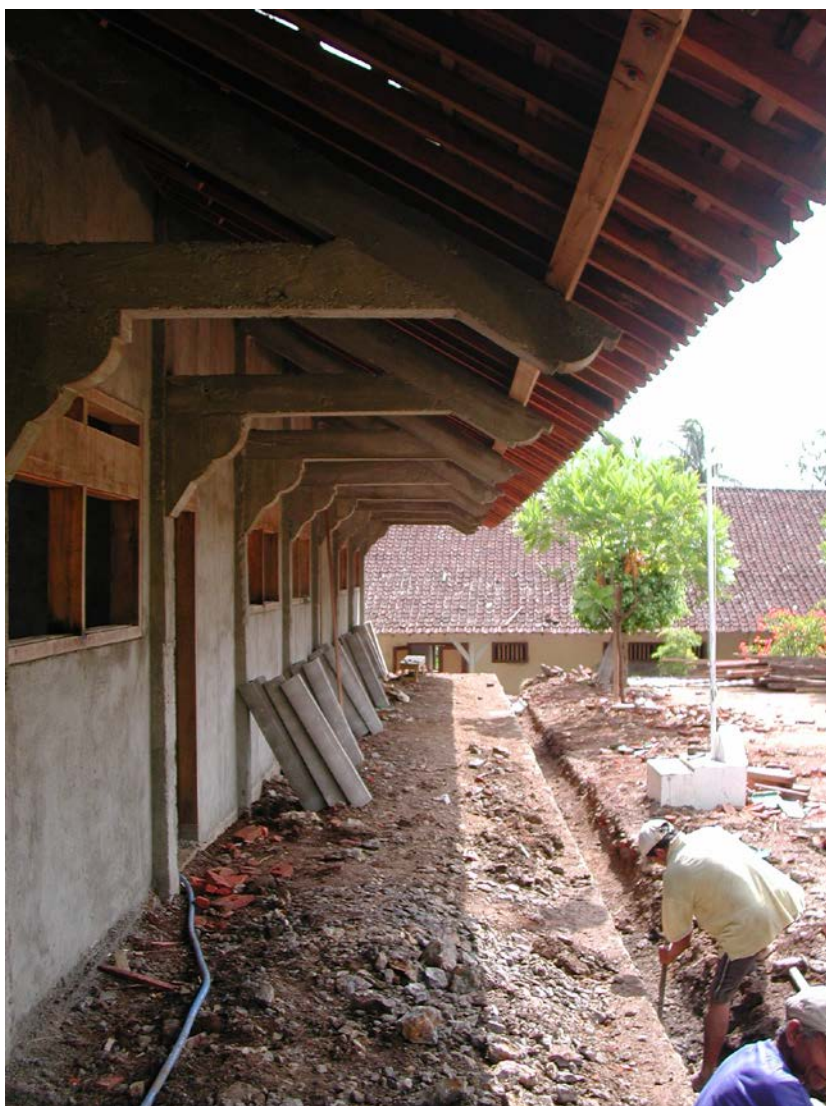
Plate 12: SDN Ketro 2 showing RC cantilevers to veranda that should be checked

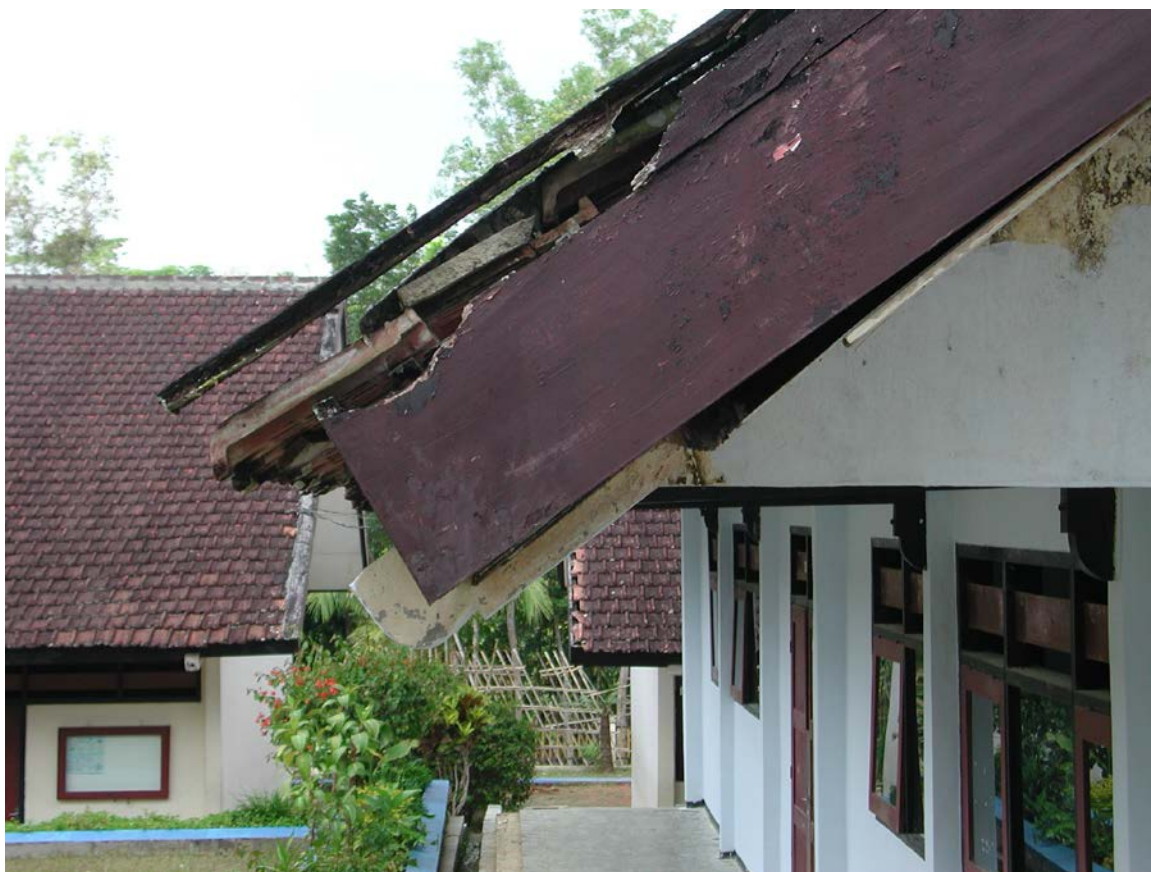
The toilets, water tank and retaining walls are well constructed and finished although the connection from the water tank is at present through a plastic garden hose! The main concern is that no repairs are being carried out to any of the roofs although this is probably the highest priority. Many verge boards and ends of roof purlins are badly rotted and if they are not replaced soon there will be major roof problems. This work should have taken precedence over the painting of the school.

Plate 13: SLTPN 2 Tulakan showing typical roof that requires urgent repair

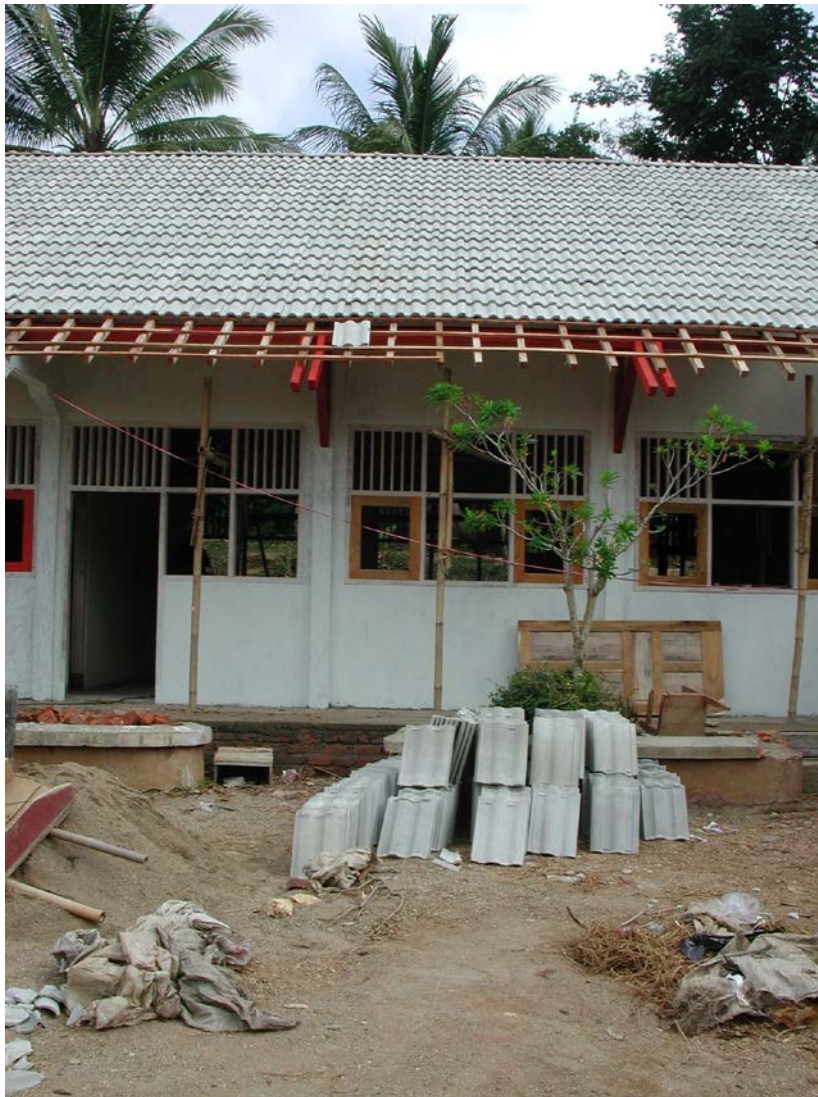
At another school site (SDN Bubakan 1) the soil is very unstable (this is known to local people and all existing school buildings are badly cracked) and to avoid settlement, buildings should have specially designed foundations.

The SCA did not comment on this or provide the school with any technical advice on the matter. The head teacher however has taken it on himself to construct concrete foundations under the concrete columns. Whether this will be sufficient to prevent subsidence and cracking, only time will tell.

possible to see the size of the reinforcement but there were only receipts for 6mm and 8mm reinforcement. The soil conditions here are very bad (probably the reason why the existing buildings are so badly cracked) and the school committee have constructed the new RC columns with RC foundations below. It is suspected that the reinforcement used for all the columns, beams and cantilevers is only 8mm and the consultants should check the structure of these cantilevers as soon as possible and make proposals for strengthening them if they are found to be under-strength. The site rises quite steeply behind the classrooms and a drain will be required here to protect the building.

Plate 14: SDN Bubakan 1 showing new building

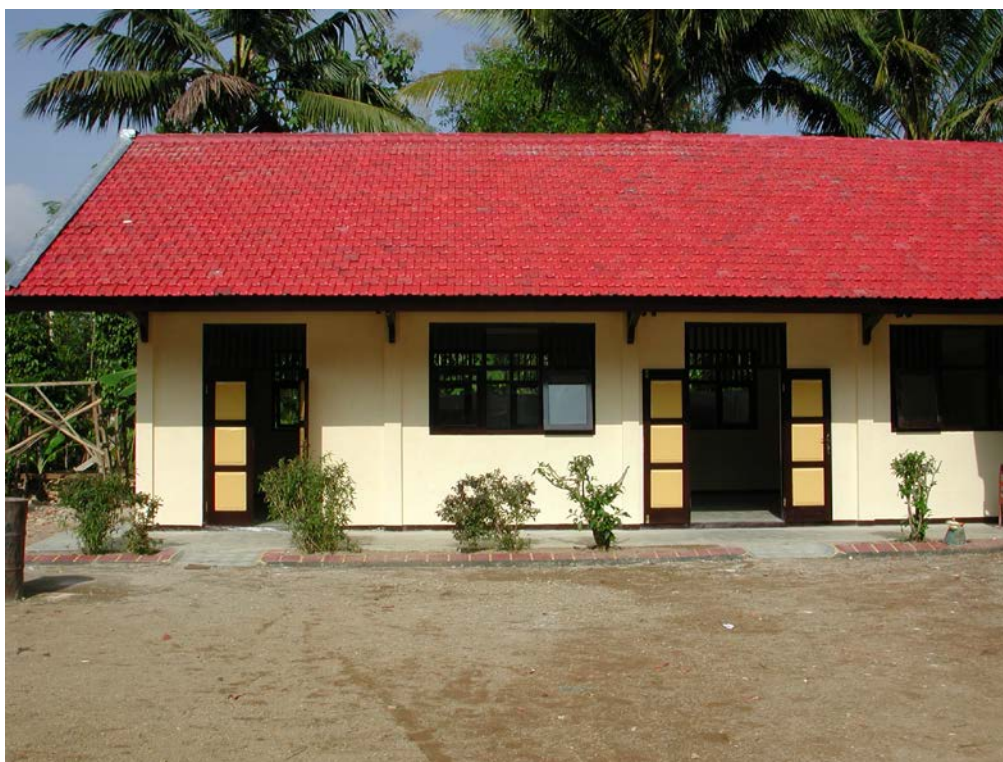
Plate 15: MIN Bungur showing new building

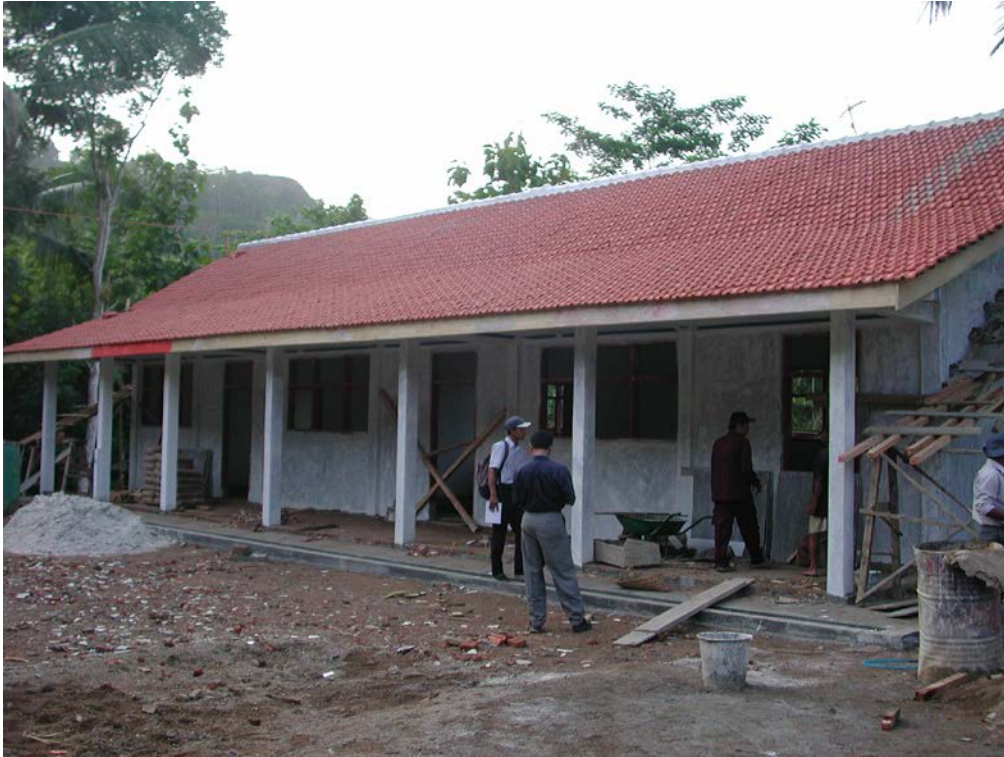
Plate 16: MIM Desa Sanggrahan showing new building

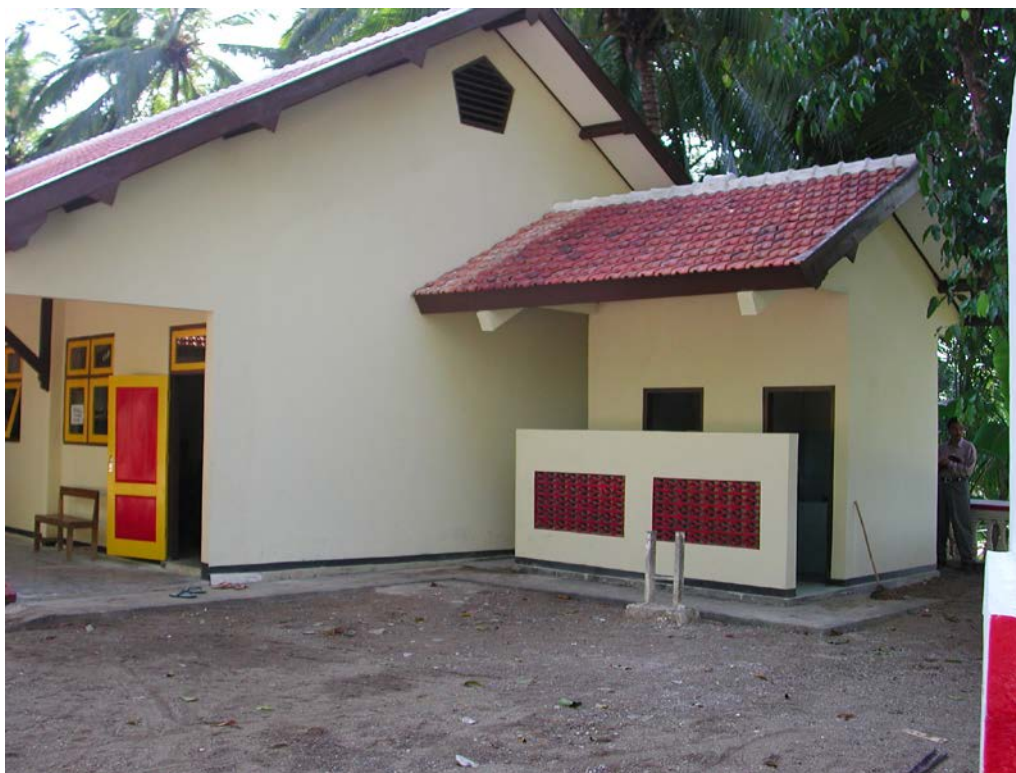
Plate 17: MI Guppi showing new toilets and large RC cantilever beams that should be checked

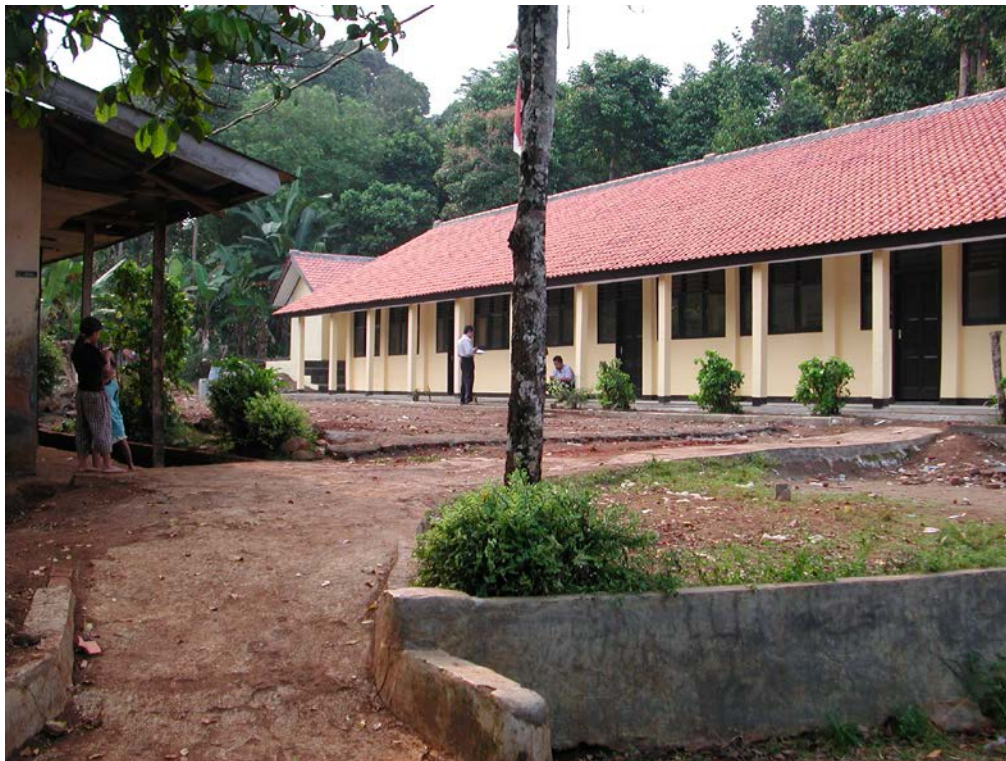
Plate 1: SDN Kadumerak showing new building with toilets at far end

The new building is finished and is constructed of rendered brick walls, RC columns, RC veranda columns and beams, timber roof trusses, clay tiled roof, white glazed floor tiles to rooms and the veranda, timber windows and panel doors. The trusses could not be seen are good neither could the concrete work which is rendered. The roof seems quite well built and is reasonably straight and the windows and panel doors are well made. The rest of the construction is not very good however: the rendering is very rough and the painting, especially to the toilets is not very good. Some of the concrete columns are not very straight or plumb, the veranda columns are

small and the reinforcement to columns and beams seems to be 8mm. This is inadequate; it should have been 10mm or preferably 12mm and the consultants should check the structure as soon as possible and make proposals for strengthening it if necessary.

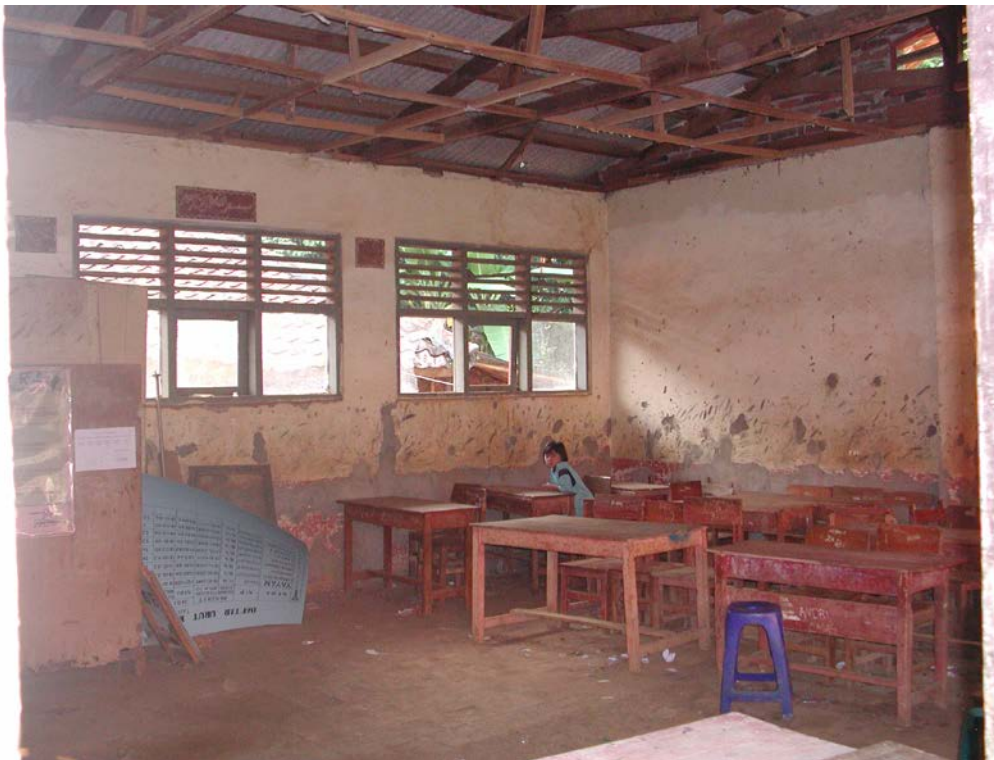
As stated above, the existing building that has not been renovated is in a very bad state of repair and if it not renovated will soon become unusable. It would have probably been more sensible therefore to have renovated both buildings to a lower standard than the one that has been renovated with new roofs and floors and whatever other elements that could have been afforded. This would have given all pupils in the school better classrooms rather only half the pupils as at present.

Plate 2: SDN Kadumerak showing inside of un-renovated building

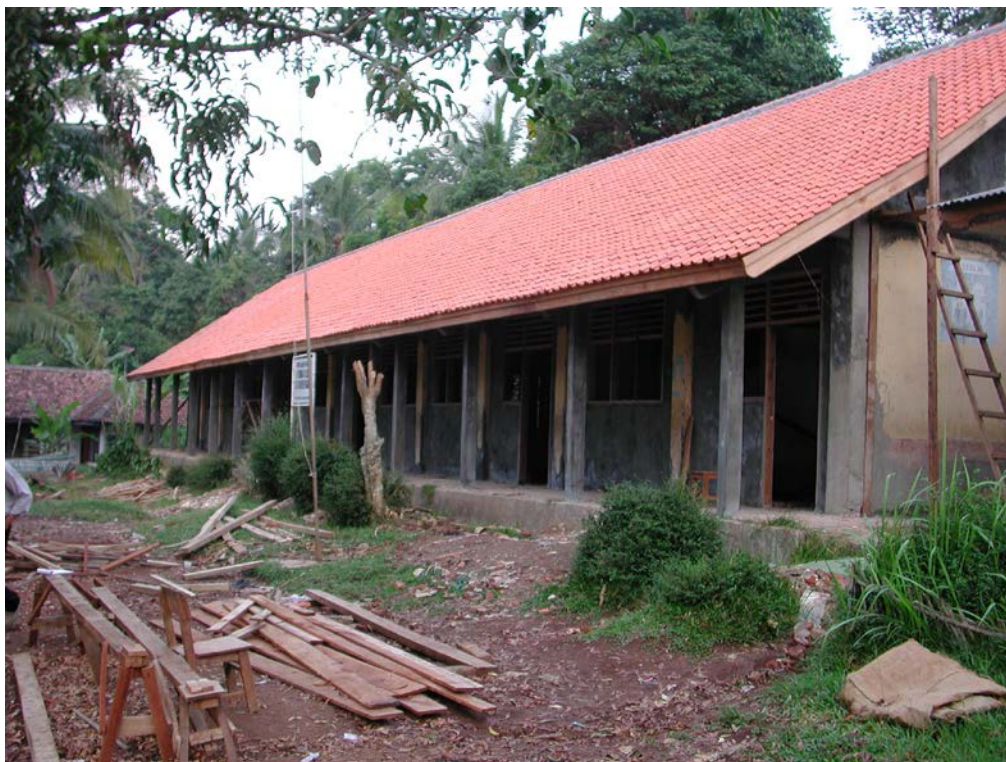
Plate 3: SDN Pagadungan 5 showing classroom building

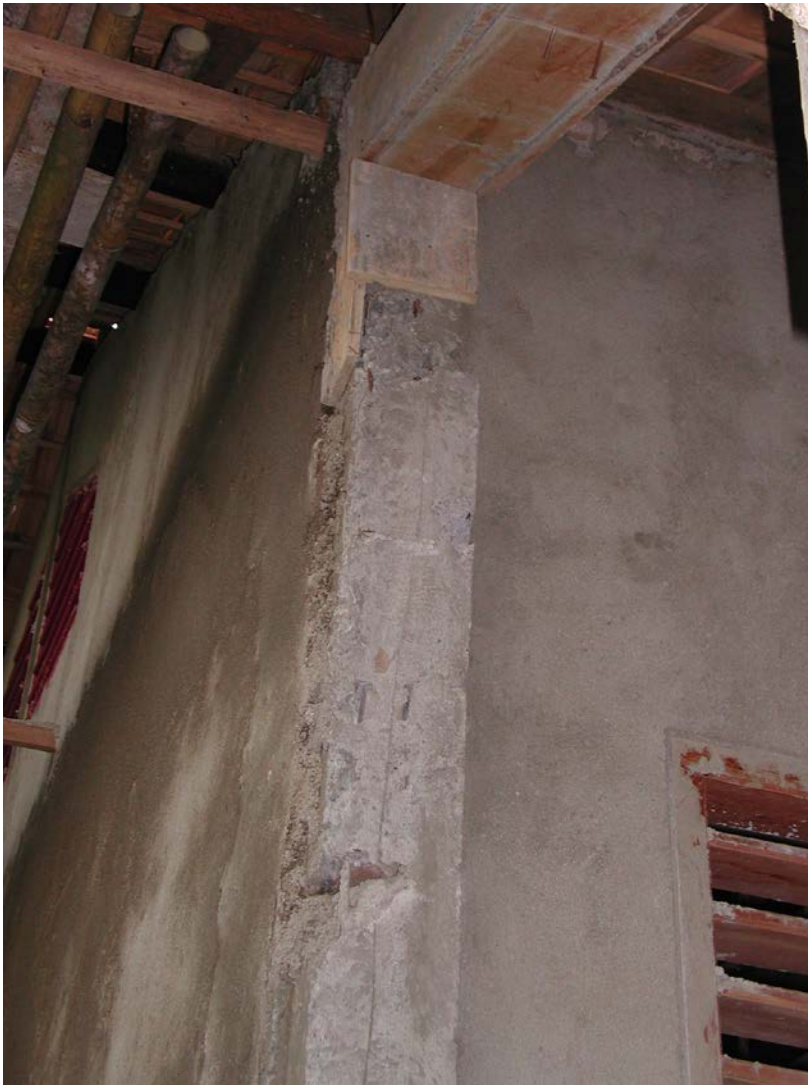
Plate 4: MIs Al-Ishlah Laksana showing poor quality concrete

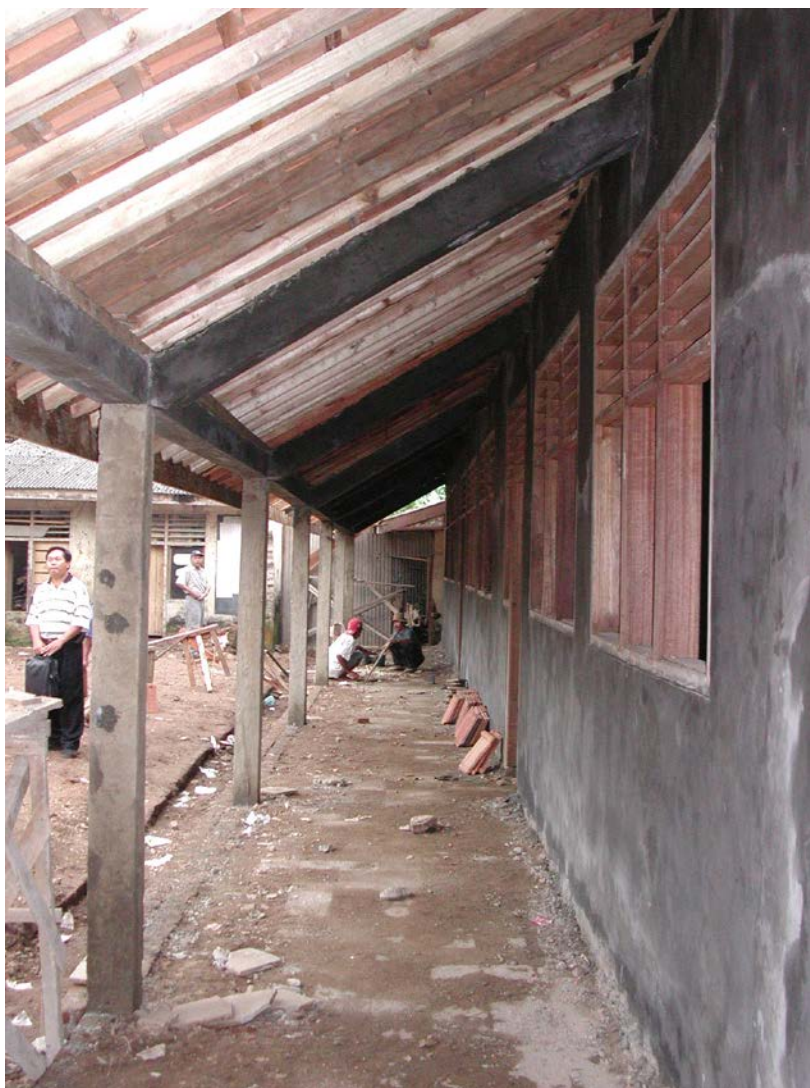
Plate 5: SDN Pandaj 1 showing veranda beams sitting over windows

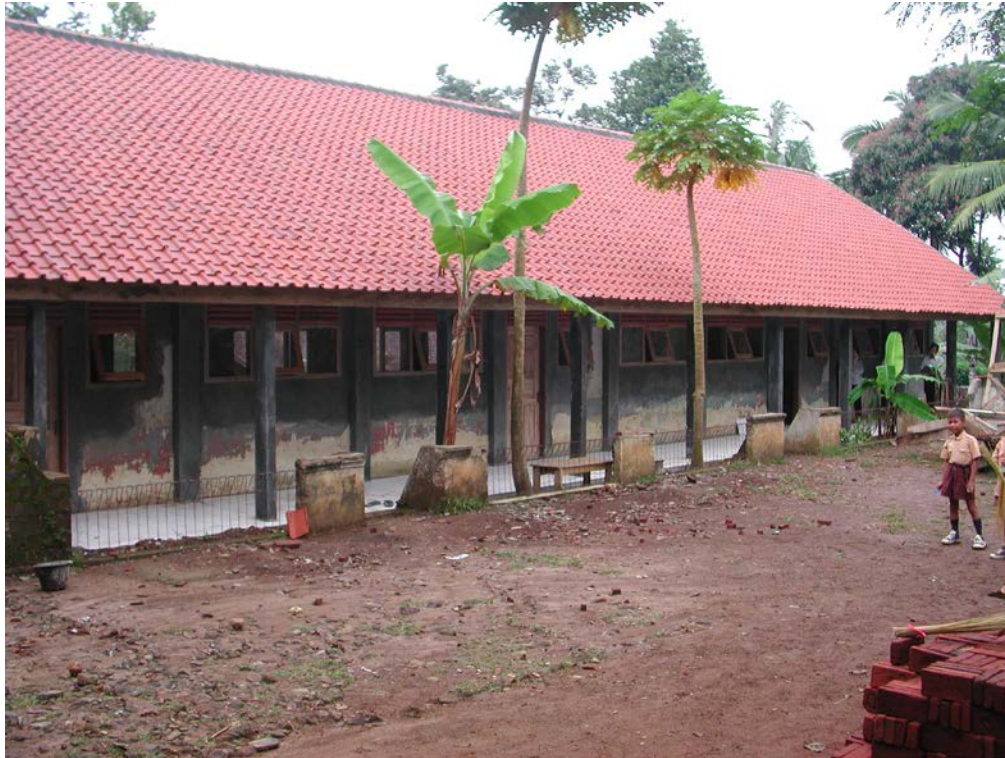
Plate 6: SDN Suka Raja showing renovated building
