**SCHOOL IMPROVEMENT GRANT PROGRAMME 2  
VISITS TO PACITAN & PANDEGLANG DISTRICTS**

**SCHOOL REHABILITATION CONSULTANT'S REPORT  
JUNE 2003**

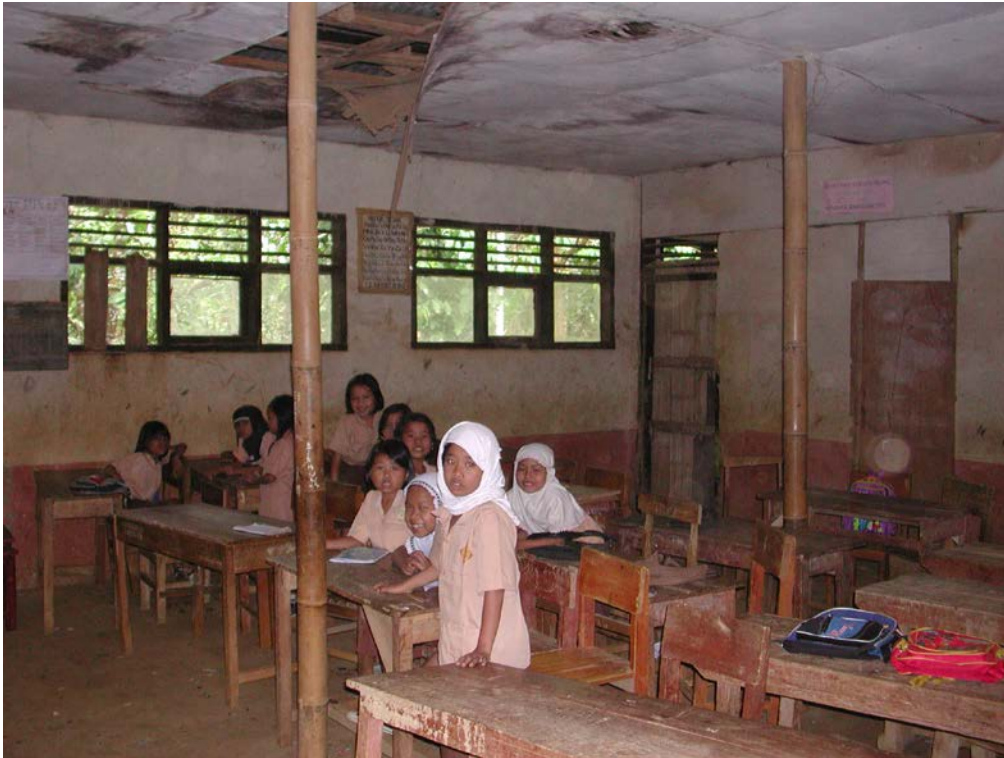
reasonable condition) and the school would have then had six classrooms that could be safely used. The SCA however did not suggest this.

Plate 6: SDN Suka Raja showing interior of un-renovated building

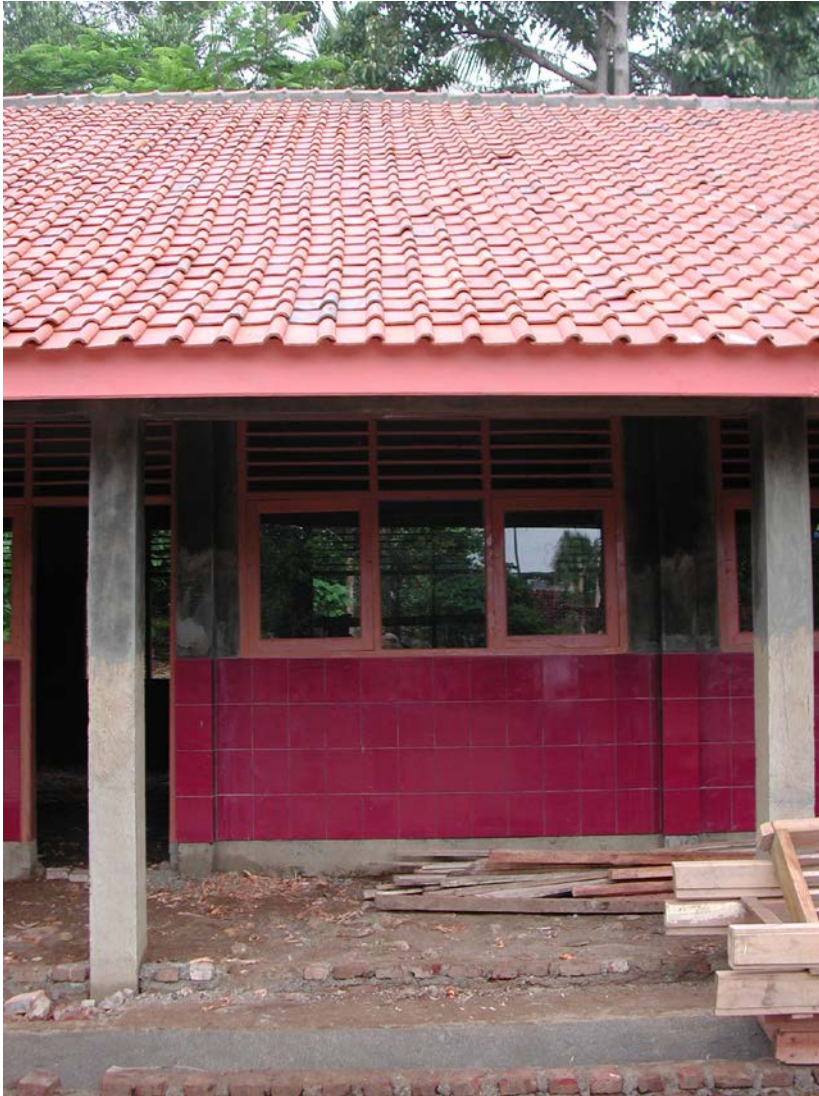
Plate 6: SDN Kerangi 1 showing renovated classrooms

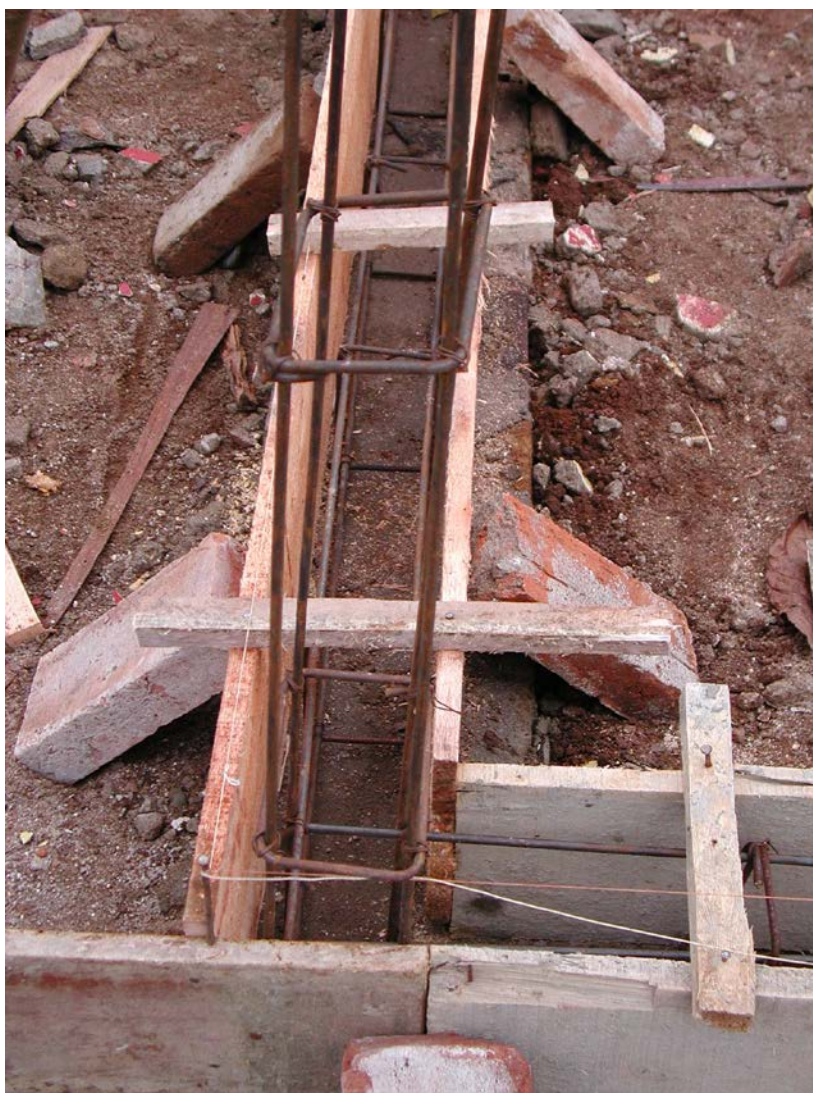
Plate 7: SDN Kerangi 1 showing 6mm reinforcement to office building

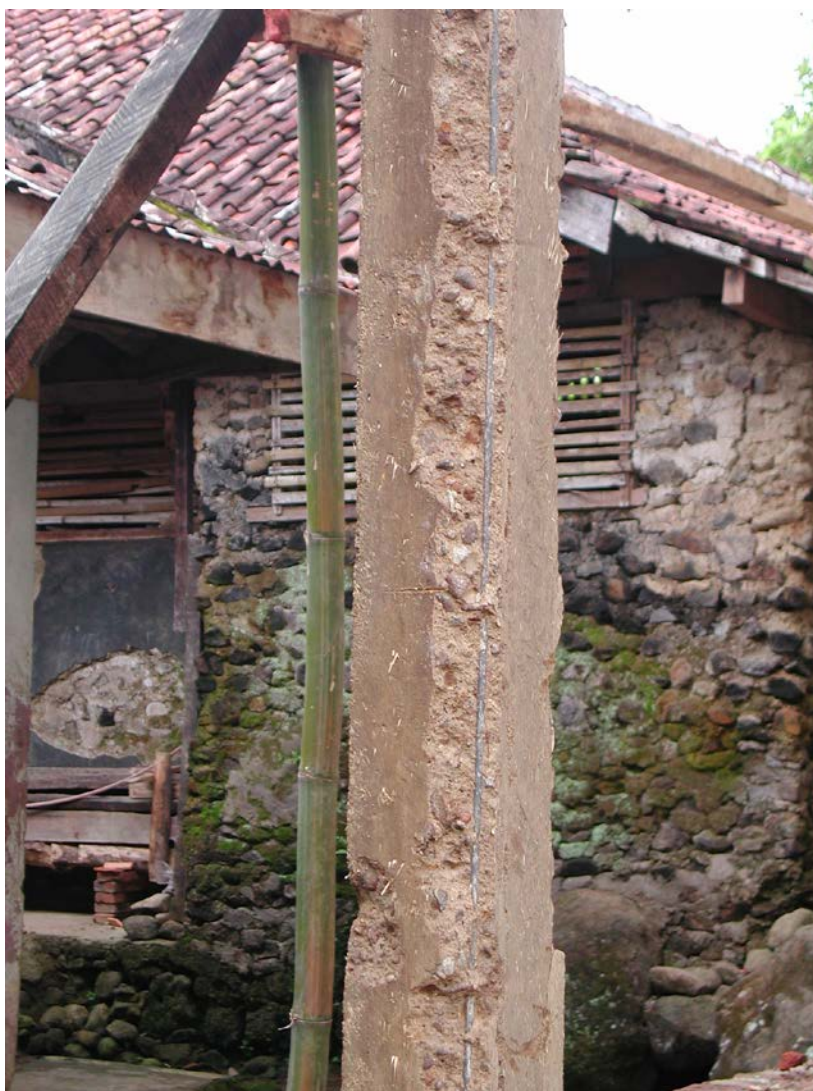
4.3 Size and position of concrete columns: At one school (SDN Banjar Negara1) the size of the freestanding columns to the veranda seems inadequate (11 x 18cm) for the height of the columns and the loads being taken.

Some walls to the renovated building are being retained and there are new columns and beams to the veranda. The building has a new clay tiled roof, new roof trusses, new fibre-cement ceilings, new ceramic tiled floors and new timber windows and panel doors. The building is quite well constructed with good roof trusses and very good windows and doors. The veranda columns however are only 18 x 11 cms and have individual foundations and the concrete is very poor generally. The reinforcement to columns and beams is 8mm.

Plate 8: SDN Banjar Negara 1 showing very poor concrete
