## **The Kingdom of Tonga**

# **Tonga Education Support Programme**

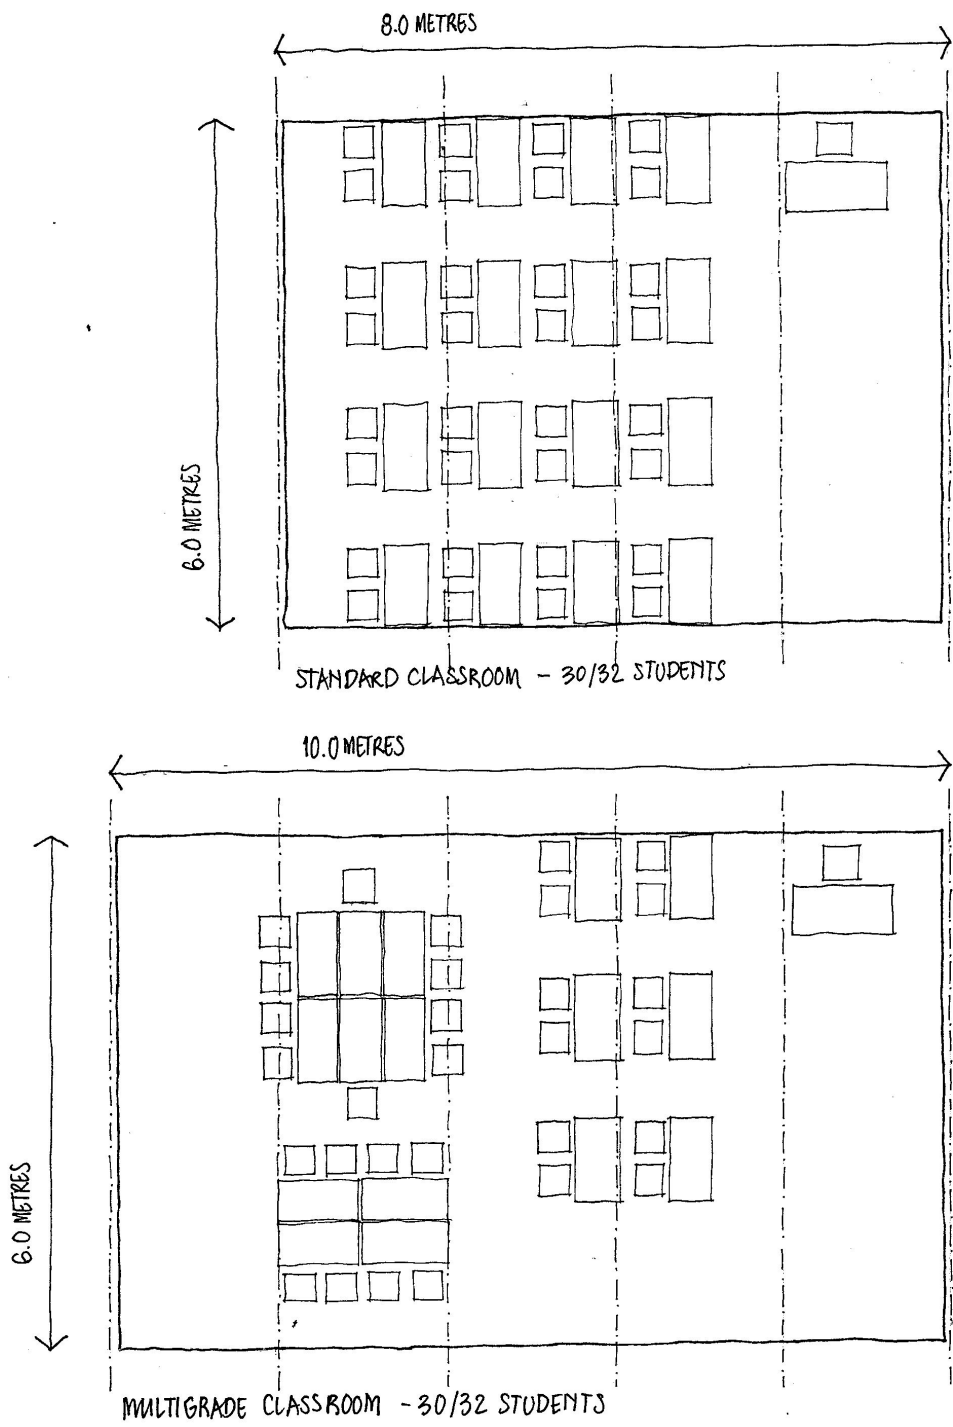
Drawing 1: Proposed standard classroom and multi-grade classroom

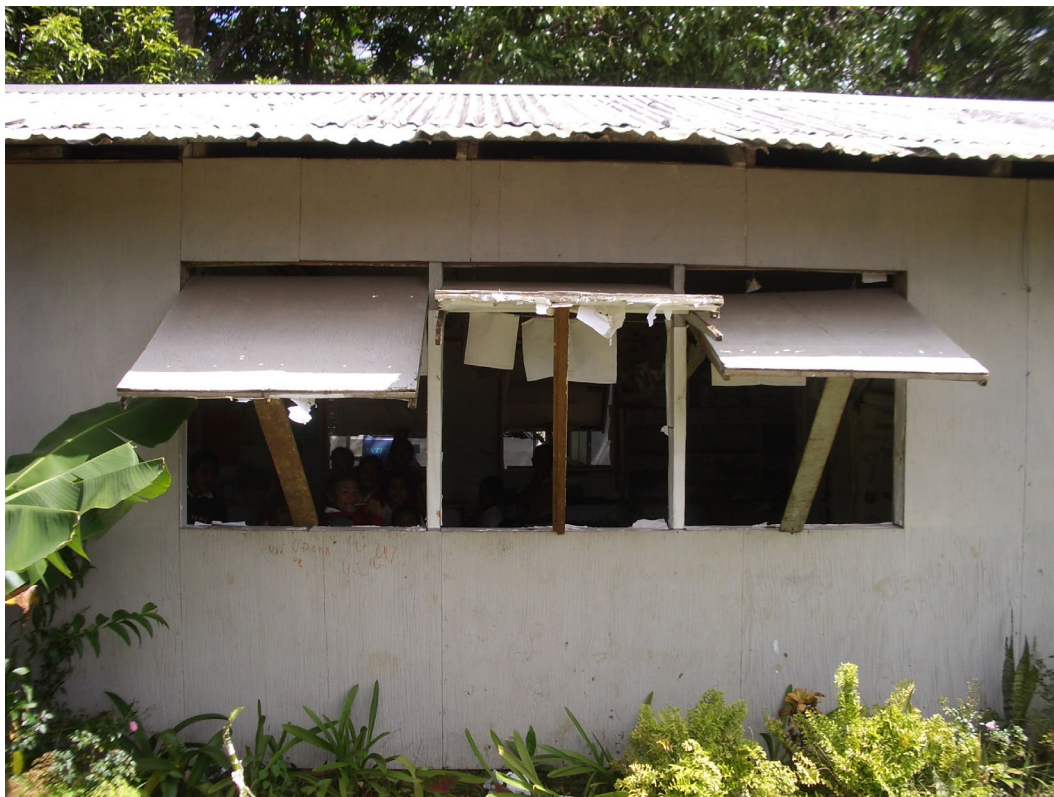
Plate 2: Classroom Building 2 showing very poor roof construction and top-hung shutters

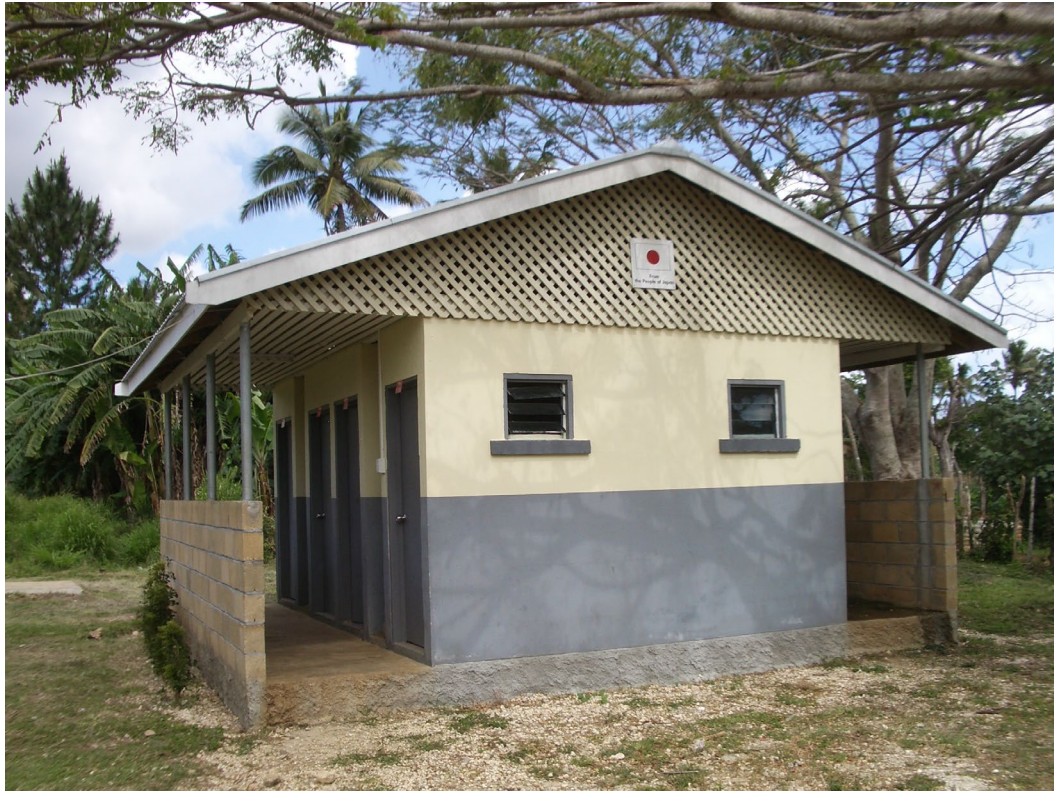
Plate 5: JICA funded toilet building. The steel posts are only built into the 15cm walls and are not properly tied down.

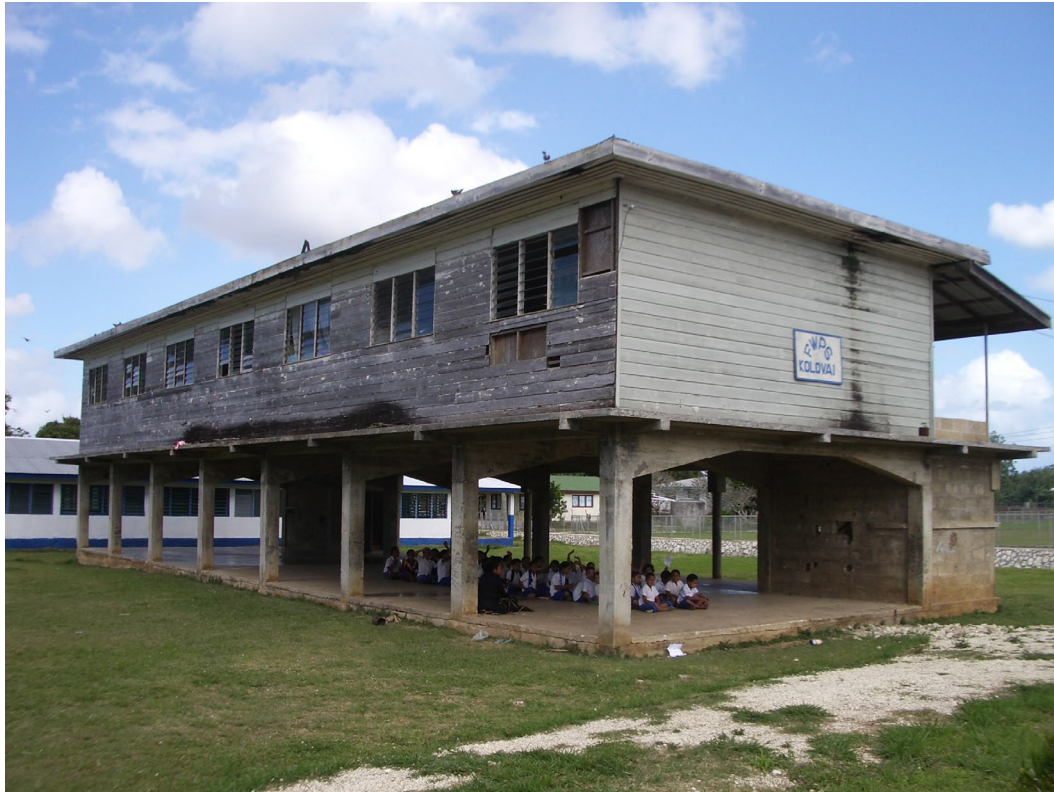
Plate 7: Two-storey classroom building; note heavy RC frame to ground floor and water-damaged walls and rusting louvre windows to first floor.
