**INDONESIA: EARLY CHILDHOOD  
DEVELOPMENT PROJECT**

**CONSTRUCTION OF KINDERGARTENS &  
BKB/POSYANDU CENTRES**

**IMPLEMENTATION SPECIALIST'S REPORT  
MAY 2002**

MAY 2002

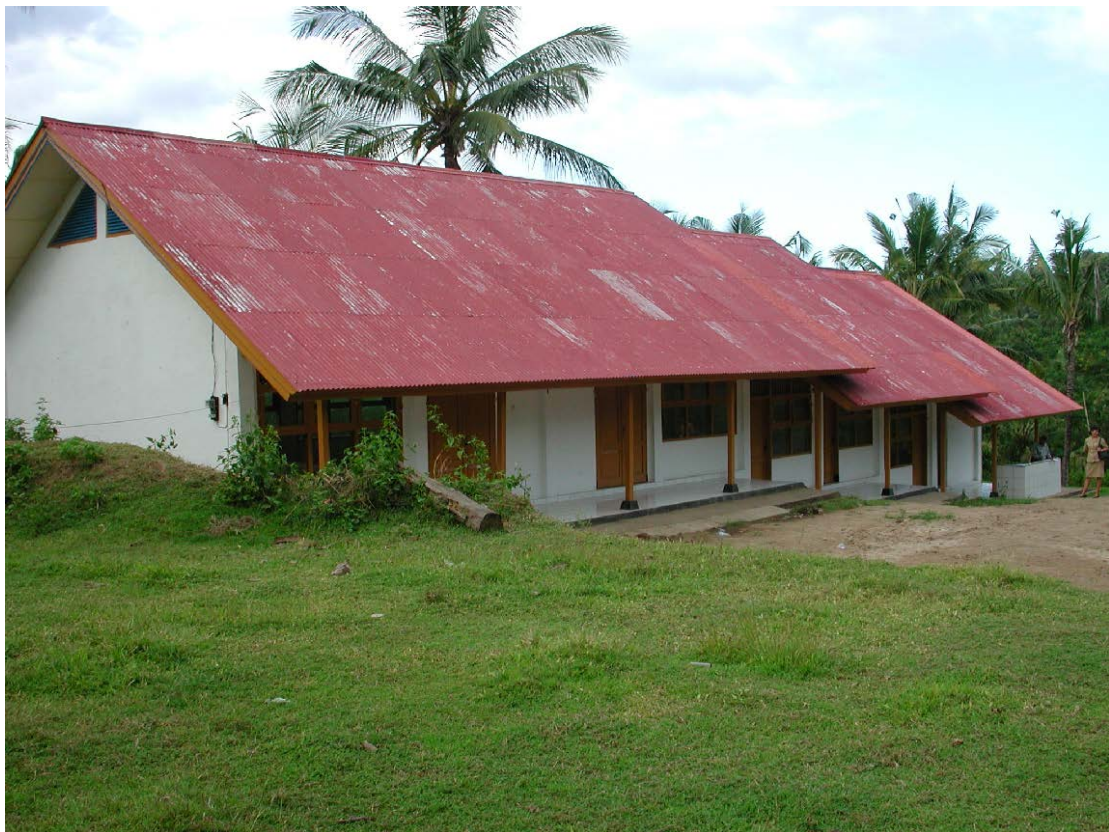
Plate 9: TK Bulian, Kecamatan Kubu Tambahan

The building was started in August and finished in December 2001 using local labour with a local supervisor. All floors including the verandas have been tiled with glazed ceramic tiles and the external ceilings have been sealed with ply panels. The veranda has timber columns and the roof is of corrugated steel sheets which have been painted (not very well; are the roof sheets and the paint to the correct specifications?). The building is on the whole well built but there are some cracks to walls and the floor tiling is not very good. The building has one metre wide paving and a storm drain all round and there is no wall or fence to the site. It is hoped that funds for the wall will be found this year.

The roof and foundation costs must have been higher than at other sites because of the sloping site and there was also the additional cost of terracing the site but the budget was not increased. The community however assisted with levelling the site and also contributed 50% of the workers pay.

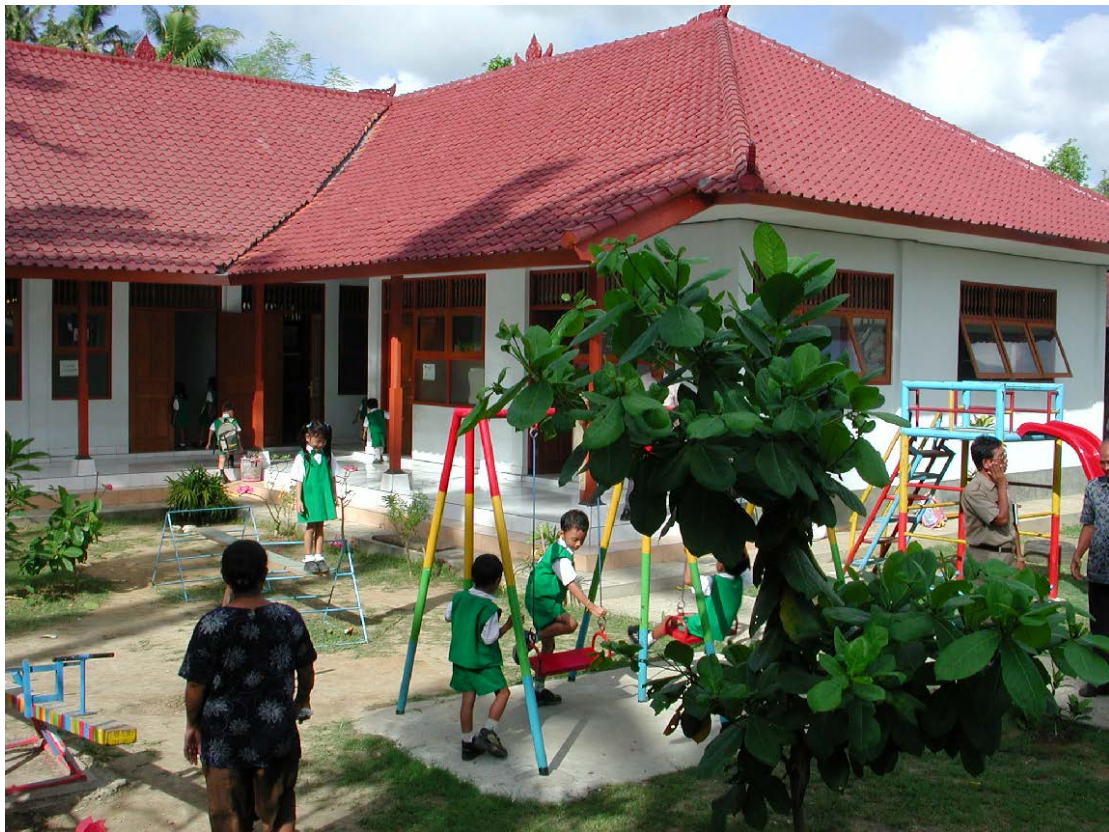
Plate 10: TK Laksana Kumara, Banjar Kaja, Denpasar Selatan

3.1 TK Laksana Kumara, Banjar Kaja, Denpasar Selatan: This new kindergarten is situated on a small urban site and the design has been modified in order for it to fit the site. The budget for the building was Rp120 million. The accommodation consists of a large classroom (9 x 8 metres), two smaller classrooms (8 x 6 metres & 8 x 3.5 metres), an office, three toilets and a small kitchen. For some reason the width of the building was increased from the standard width. The kindergarten has an electricity connection and is connected to the town water supply. The kindergarten is clean and nicely kept.

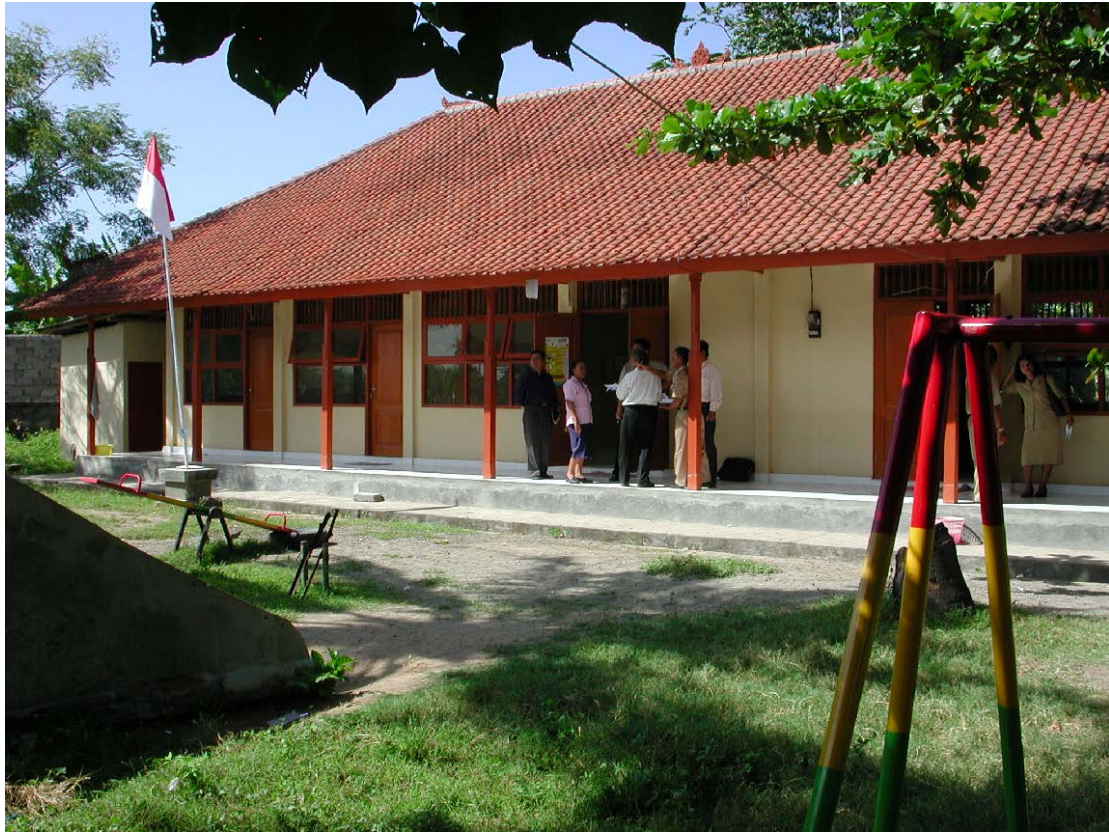
Plate 11: TK Kumara-Sari V, Serangan, Denpasar Selatan

The building was started in January and finished in June 2001 using local labour with a local supervisor. The building has a tiled roof and timber veranda columns. All floors including the verandas have been tiled with glazed ceramic tiles and the veranda ceiling has been sealed with ply panels. The large classroom has two tungsten light fittings! The building is quite well built, painted and finished but the well is only 8 metres from the septic tank and soakaway. The soil here is very sandy and porous and the water table is probably quite high. There is great danger therefore of contamination of the well by the soil drainage and a new well should be constructed at least 30 metres away from the septic tank and soakaway.

The total area including walls but not verandas is 150m<sup>2</sup> and the total budget without the administration fee was Rp116,505,800. The community however donated Rp19,000,000 giving a total cost of Rp135,505,800 and a cost per square metre of Rp903,372. This cost however includes a new wall round the site, paving and drains around the building, a small 'puja' (temple) and the septic tank and soakaway.

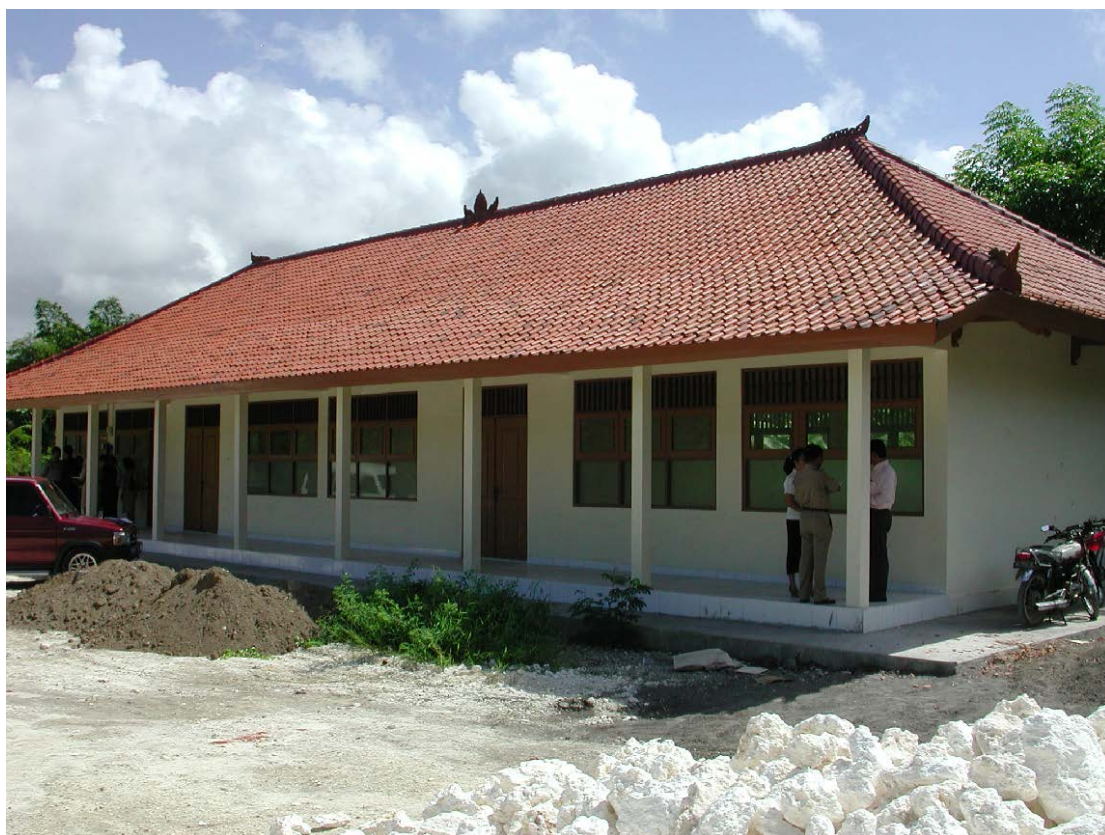
Plate 12: TK Sanur Kauh, Werdhi Kumara, Denpasar Selatan

3.3 TK Sanur Kauh, Werdhi Kumara, Denpasar Selatan: This is a new kindergarten on a new site in a middle class housing area and the budget was Rp116 million. The accommodation consists of the standard large classroom, an office, a kitchen and store and toilets (the security room has been omitted). The toilets have been reduced in number from five to three. The kindergarten has an electricity connection and is connected to the village water supply.

The total area including walls but not verandas is 150m<sup>2</sup> and the total budget without the administration fee was Rp112,520,000. However the community donated Rp239,000,000 giving a total cost of Rp351,520,000 and a cost per square metre of Rp2,343,467!!!. This cost does however include the site wall, the filling

of the site, a small puja, the external paving (but no storm drains) and the septic tank and soakaway.

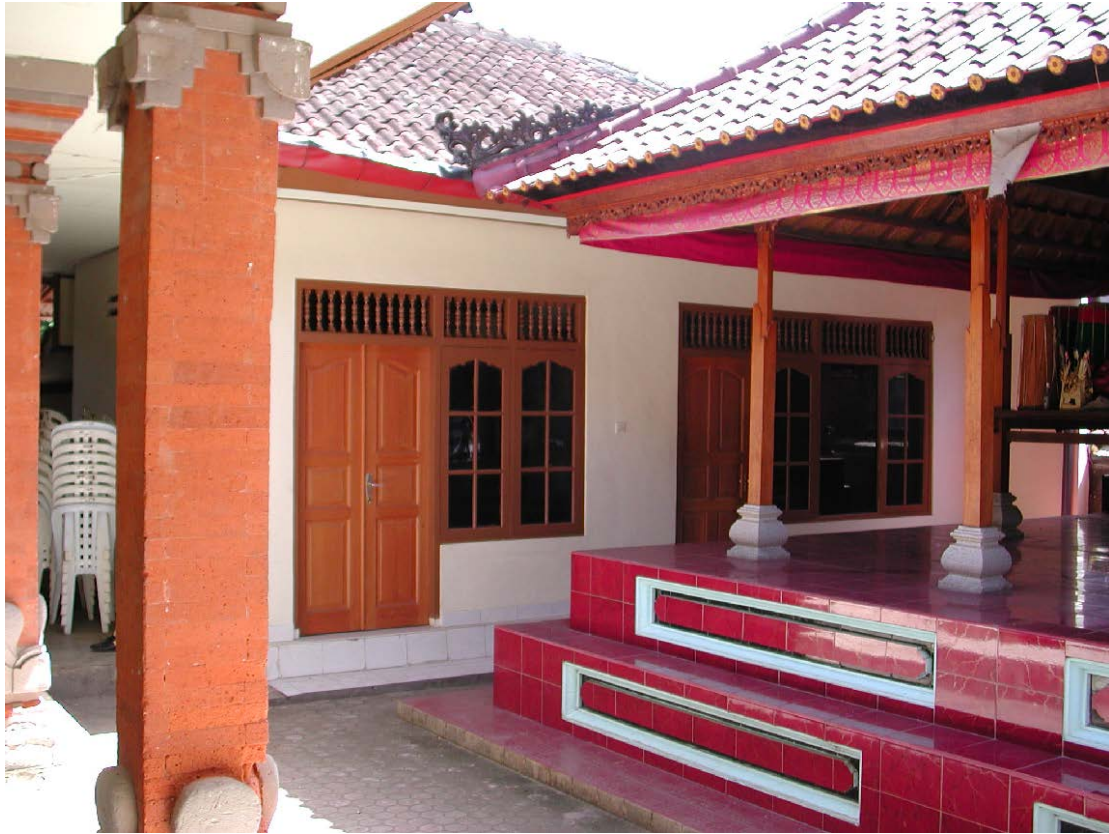
Plate 14: BKB/Posyandu Post, Sindu Kelod, Samur, Denpasar Selatan

3.5 BKB/Posyandu Post, Sindu Kelod, Samur, Denpasar Selatan: This BKB is situated in the village 'banjar' (meeting place). An existing building in one corner of the banjar, consisting of an office and store has been very well renovated with new doors, tiled floors and painting. The standard budget was Rp3 million but the community contributed a further Rp10 million.

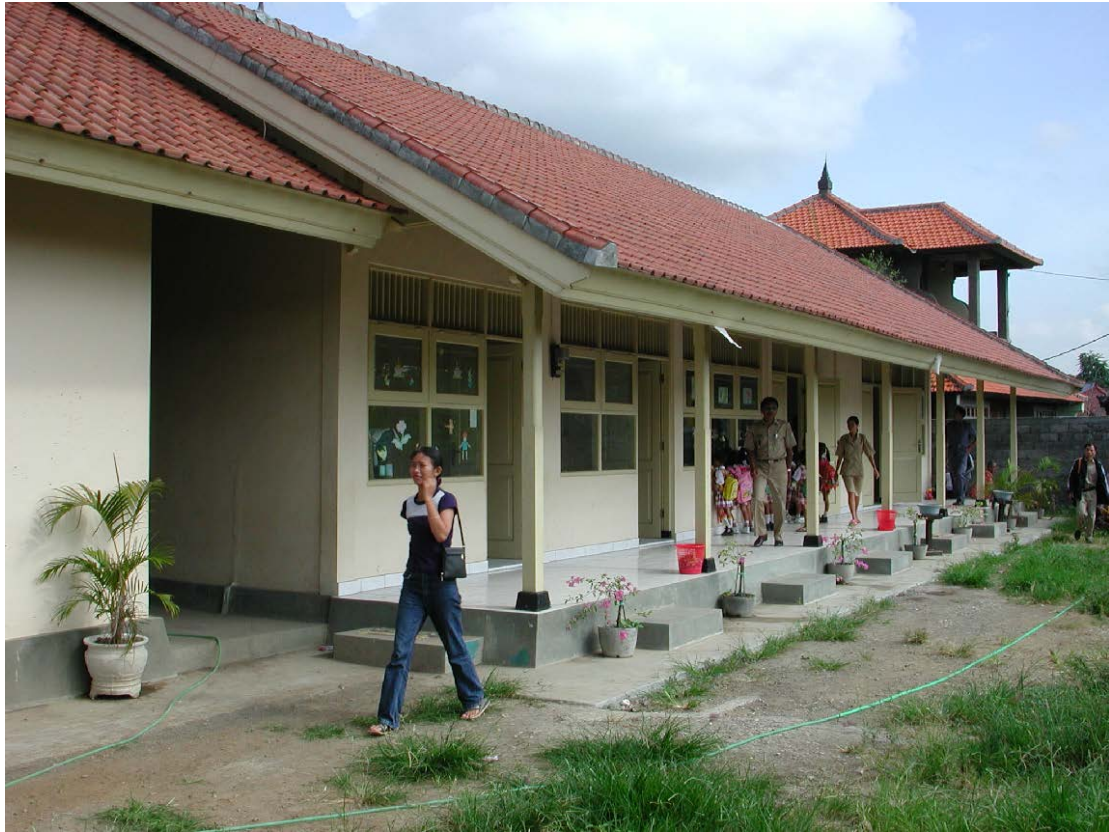
Plate 15: TK Sabana Sari, Padang Sambian Kajar, Denpasar Barat

3.6 TK Sabana Sari, Padang Sambian Kajar, Denpasar Barat: This is a new kindergarten situated on a very small site in a middle class housing area on the edge of the village. The site sloped steeply and has had to have approximately 2 metres of fill at the front. There are two buildings set at different levels. The higher building has three toilets and a security room and no veranda and the lower building has a kitchen and store, an office and a large, standard classroom. The budget for the buildings was Rp120 million. The kindergarten has an electricity connection and a deep well and electric pump for its water supply. There are also two small pujas on the site.

The buildings have tiled roofs, timber veranda columns, glazed ceramic tiled floors and veranda, ply ceilings but no ceilings to the veranda or elsewhere externally. The classroom has 8 tungsten light fittings. The building is well built with nice tiling, good joinery and painting and good roof timbers. Some ceiling panels are coming loose however. The site has been filled with walls all round and the buildings have paving all round. There are also steps up to a higher level at the entrance where there is a simple covered area for play and parking motor cycles. The steps on the site are very high; much too high for small children. The construction work started in June and was finished in December 2001 and took 1200 man days. The supervisor received Rp35,000 a day, the foreman Rp35,000 a day, skilled workers Rp30,000 a day and labourers Rp25,000 a day.

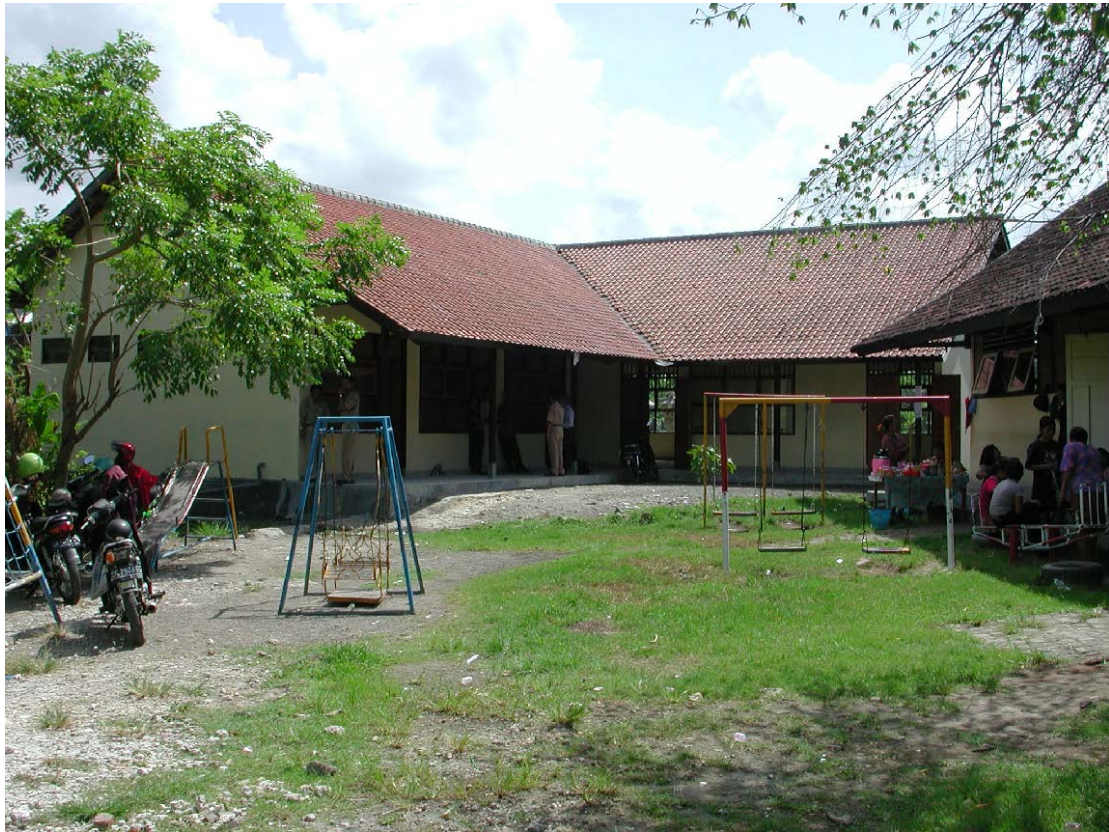
Plate 16: TK Widya Santhi 2, Ubang, Denpasar Barat

3.7 TK Widya Santhi 2, Ubang, Denpasar Barat: This existing kindergarten is situated on a small site in the village bounded on one side by a large stream and on the other by a main road. The budget was Rp116 million. The kindergarten is at present using a semi-permanent building with rendered brick walls to 1.2 metres

high and timber framing above with bamboo panelling. It has two classrooms and an office all of which are very dark. There is a new L-shaped building constructed by the project with 3 toilets, a small kitchen, a security room and an office in one wing and two classrooms, one small and one larger in the other. The kindergarten has an electricity connection and will be connected to the town water supply. There are two small puras on the site.

The building was started in June and finished in December 2001 using local labour with a local supervisor. The buildings have tiled roofs, timber veranda columns, floors to rooms and verandas are tiled with concrete tiles in accordance with the original specification. Ceilings are of ply panels and there are no external ceilings. The building is well built with good joinery and roof timbers but the painting, especially to the ceilings is not very good. There are also some cracks to walls and some ceiling panels are coming off. There are two 600mm fluorescent light fittings to the larger classroom. There is no paving or drains around the building. There is a temporary bamboo fence along the road side of the site which it is hoped to replace this year with a permanent fence.

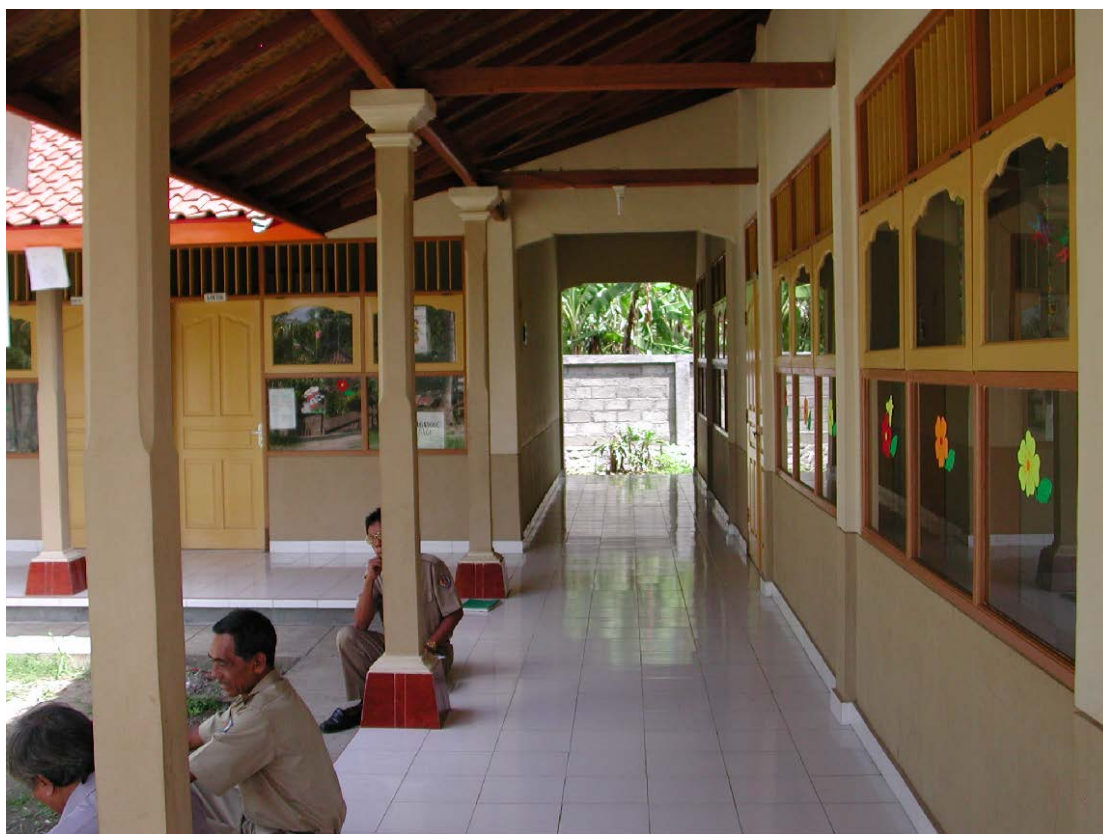
Plate 17: TK Kantika, Peguyangan Kaja, Denpasar Barat

The construction work started in June and was finished in December 2001 and took 1875 man days. Skilled workers received Rp30,000 a day and labourers Rp25,000 a day. The CS visited the site once a week and was very useful.

The total area including walls but not verandas is 165m<sup>2</sup> and the total budget without the administration fee was Rp112, 520,000 but the community contributed Rp46 million giving a total cost of Rp158,520,000 and a cost per square metre of Rp960,727. This cost however includes the paving round the building, the new wall and pura and the septic tank and soakaway.

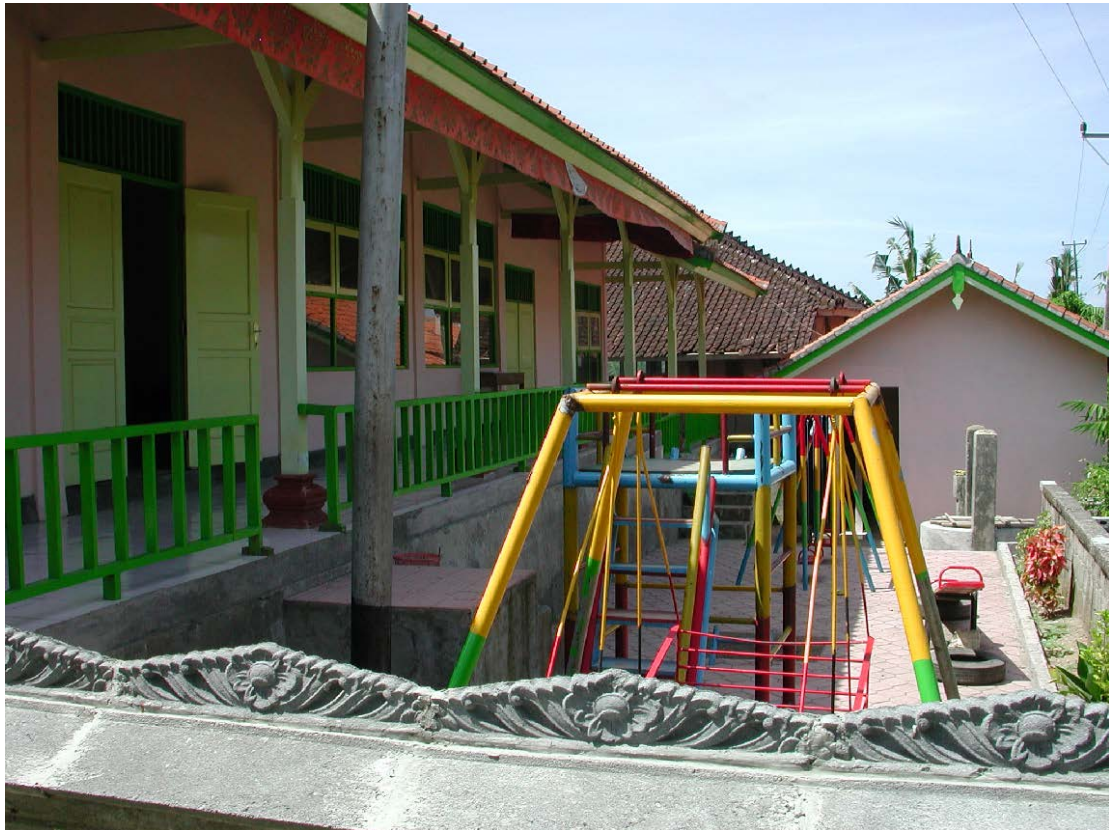
Plate 18: TK Kumara Windhu Kencana 1, Penatih, Denpasar Timur

3.9 TK Kumara Windhu Kencana 1, Penatih, Denpasar Timur: This is a new kindergarten situated on a very small site off a main road with a school on one side and a large stream on the other. The site slopes steeply in two directions. The kindergarten has been constructed in two buildings. The higher building is set at two levels and contains a large classroom (that has been subdivided into a classroom and office) and a smaller classroom and the lower building has a small kitchen, a store, a security room and three toilets. The budget for the buildings was Rp116 million. The kindergarten has an electricity connection but no water supply yet.

The buildings have tiled roofs, timber veranda columns, glazed ceramic tiled floors and veranda, ply ceilings but no ceilings to the veranda or elsewhere. The large classroom has 3 tungsten light fittings. The building is reasonably finished but there are some quite bad cracks to walls. The site has been levelled, filled and paved with walls all round. There are very high steps between the various levels, much too high for small children. The handrail to the higher building is not very well designed or built; the CS should have designed a better one. It was obviously a very difficult and expensive site to develop.

The total area including walls but not verandas is 171m<sup>2</sup> and the total budget without the administration fee was Rp112,520,000 giving a cost per square metre of Rp658,011. This cost does not include the cost of filling and levelling, paving, the boundary wall or the small pura, the cost of which (RP19 million) was contributed by the community.

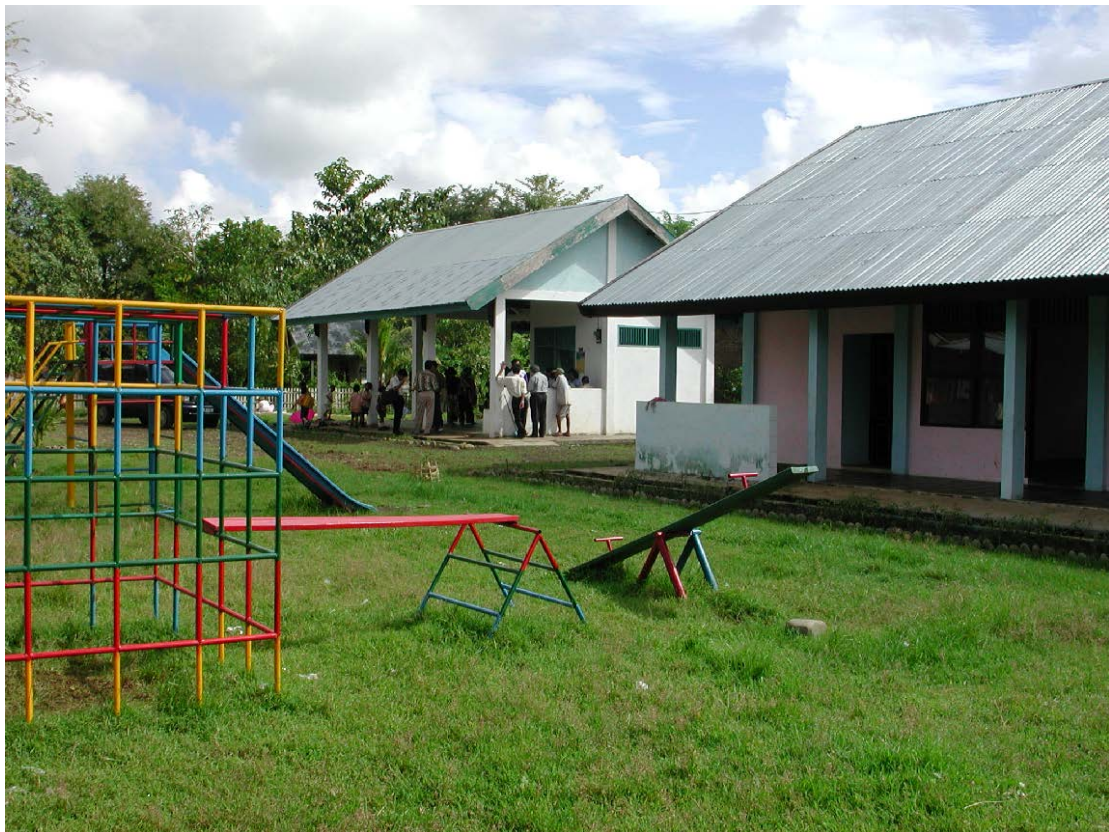
Plate 1: TK Pusat Padu Bunga Mawar, Bonto Manai, Kecamatan Bonto Makassar

- 2.1 **TK Pusat Padu Bunga Mawar, Bonto Manai, Kecamatan Bonto Makassar:** The kindergarten is situated on the same site as a BKB/Posyandu Post. The site is

large, flat and rather wet and situated on the edge of the village. The BKB Post is the standard design with a small office/interview room and a large covered waiting area/meeting space. The kindergarten accommodation consists of the standard large classroom, an office, a kitchen/store, a security room and 5 toilets. The kindergarten has an electricity connection and is connected to a well with an electric pump at the far end of the site well away from the septic tank and soakaway. The sites for both buildings have registration certificates from BPN, the national land authority. The site is not fenced but does have a hedge to three sides but not the front. The kindergarten is however set well back from the front of the site. The budget for the kindergarten was Rp120 million and for the BKB/Posyandu Post Rp20 million.

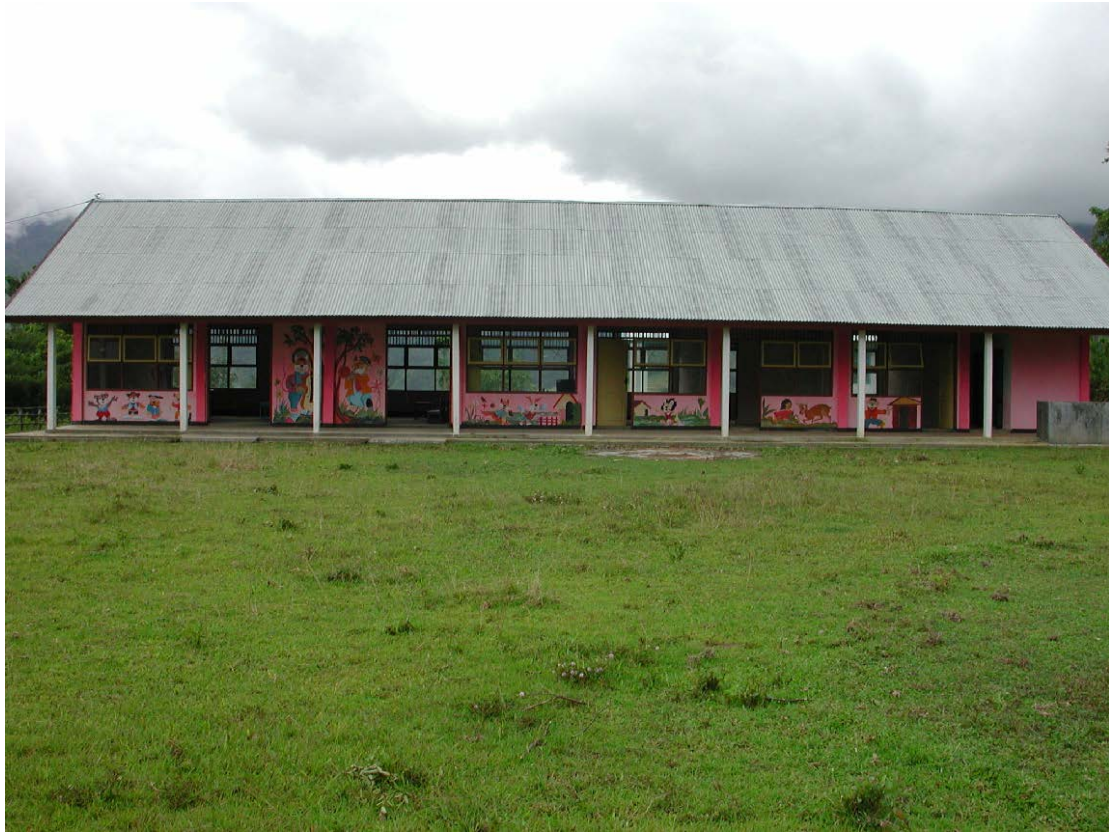
Plate 2: TK Pusat Padu Bulaengta, Gantarang, Kecamatan Tinggi Mancang

- 3.2 TK Pusat Padu Bulaengta, Gantarang, Kecamatan Tinggi Mancang: The site for this kindergarten and BKB/Posyandu Post is situated in a remote rural village 7 kilometres from the nearest main road up a hilly, rough, stone road. The site is on a hillside behind the village office and a primary school. The site slopes and has been cut and levelled. The BKB Post is the standard design with a small office/interview room and a large covered waiting area/meeting space. The kindergarten accommodation consists of the standard large classroom, an office, a kitchen/store, a security room and 5 toilets. The kindergarten has an electricity connection and is connected to the village supply from a spring further up the hill. The sites for both buildings have registration certificates from BPN, the national land authority. The site is fenced with a bamboo fence. The budget for the kindergarten was Rp120 million and for the BKB/Posyandu Post Rp20 million. The village has provided and is paying for a watchman.

The kindergarten will start operating in June/July when the teachers return from training. There will be 50 children in two classes and two teachers. The building is at present being used one day a week for teaching the Koran to 60 students. The kindergarten has 25 sets of classroom furniture, desks and chairs for teachers and outside play equipment.

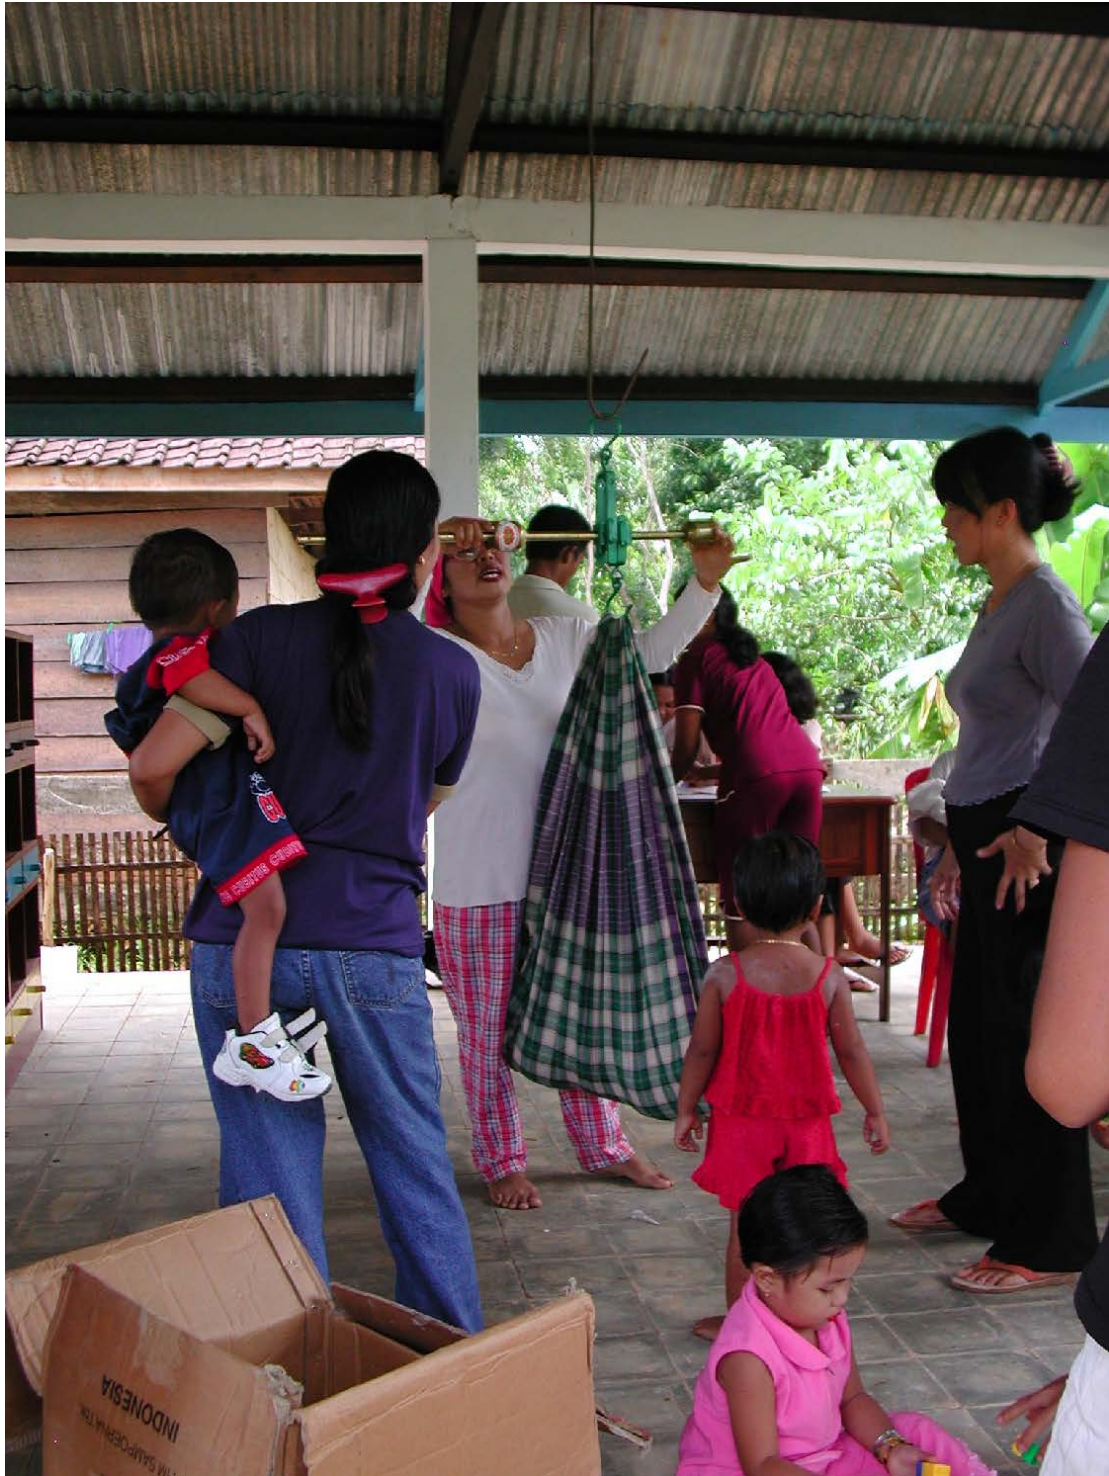
Plate 4: BKB/Posyandu Post, Benjaya, Kecamatan Bonto Bakau

The total area of the BKB/Posyandu Post including the waiting space is 56m<sup>2</sup> and the budget was Rp20 million less 3% giving a construction budget of Rp19,400,000 and a square metre rate of RP 346,429.

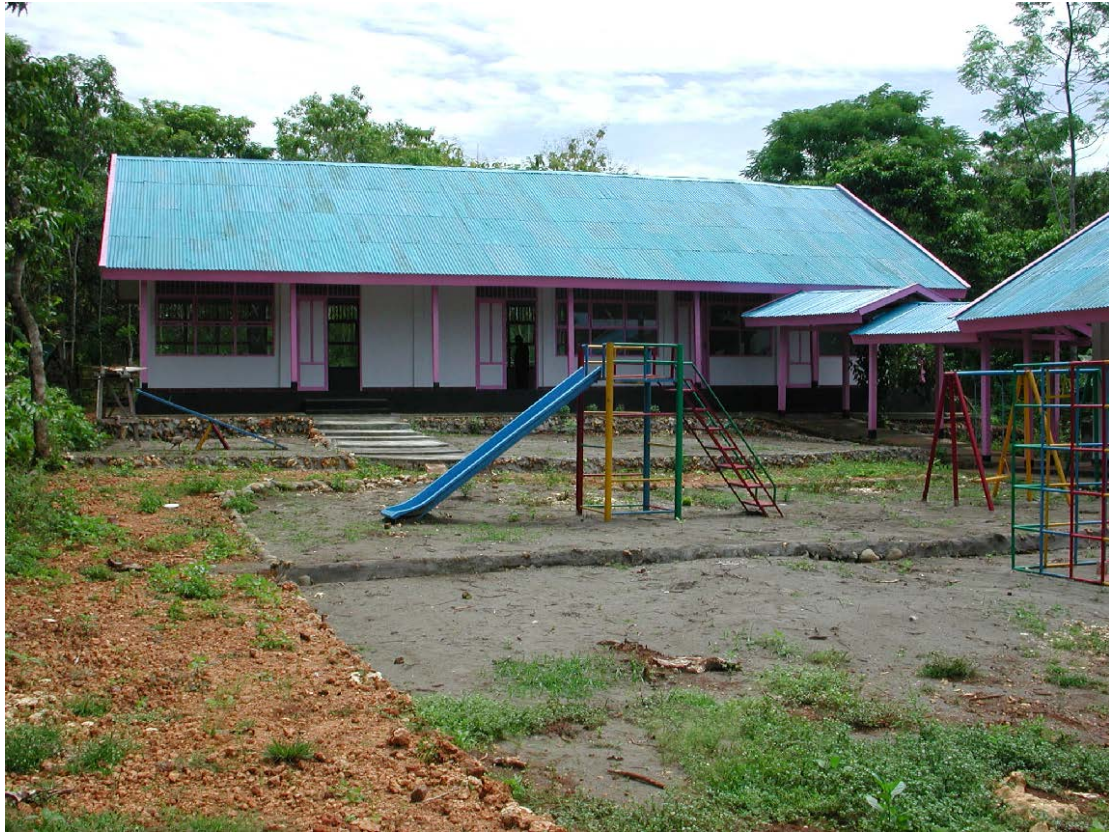
Plate 5: TK Kusuma Wijaya, Benjaya, Kecamatan Bonto Bakau

generally well built but the rendering, painting and finishing is not very good and the tiled floors require cleaning. There is one settlement crack to one wall. All painted surfaces require a further coat of paint. The toilets are neatly tiled. The external walls do not go right up to the roof at the eaves and birds and bats can gain entrance. As has been stated the site is very wet and there is standing water in several places including over the septic tank. A cut-off drain should be built across the side of the site where water is entering and it was agreed that the well should be built behind the kindergarten up a slight hill at least 15 metres from the septic tank not where it was planned to put it very close to the septic tank. The site will also probably require more fill.

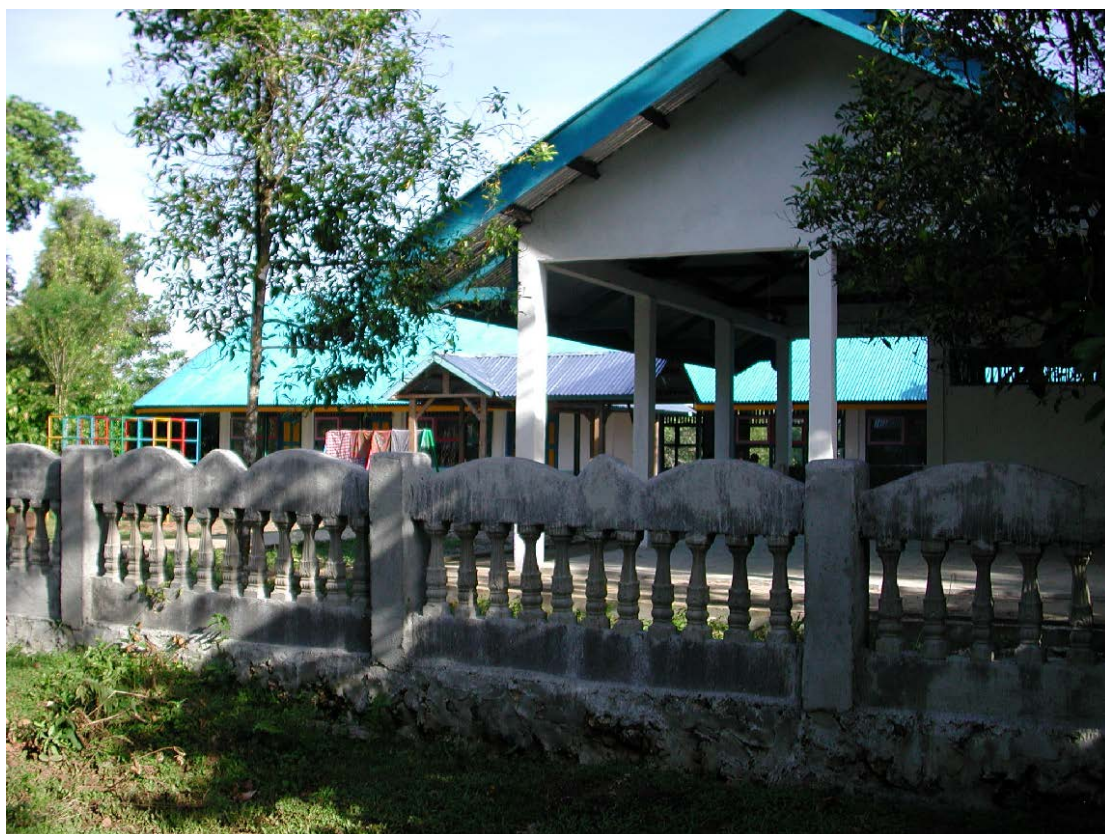
Plate 7: TK Julu Atia, Patiroang, Kecamatan Kajang

The kindergarten will start operating in June/July when the teachers return from training. There will be 50 children in two shifts and two teachers. The kindergarten already has classroom furniture and outside play equipment but is not being used. The BKB/Posyandu Post is also not yet being used.

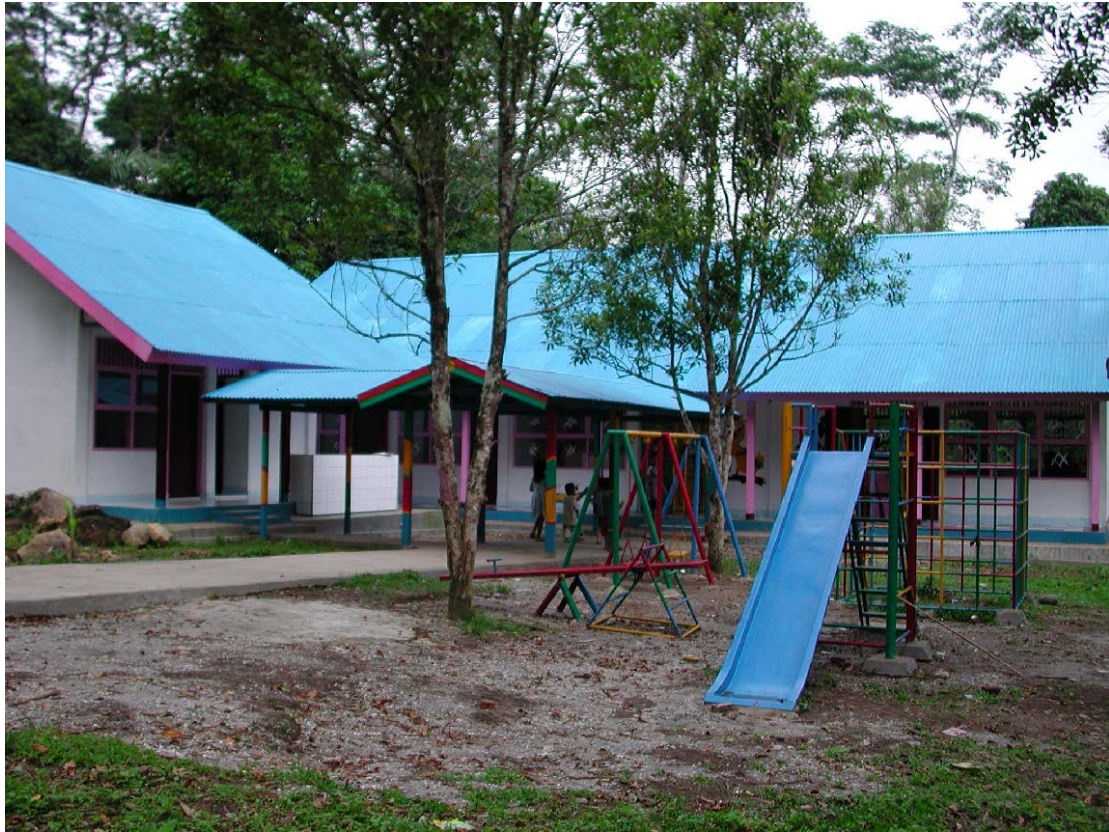
Plate 8: TK Bunga Mawar, Bonto Mate'ne, Kecamatan Bulukumba

The building has a corrugated steel roof on timber trusses and purlins, fibre-cement ceiling panels and timber windows and doors. All floors including the verandas have been tiled with glazed ceramic tiles and the external ceilings are sealed with fibre-cement sheets. The veranda has timber columns. The large classroom has 8No tungsten light fittings. The toilets have glazed ceramic tiles to floors and walls. The building has paving all round and drains to the front of the main building. The building is generally well built but the external rendering is very poor. The joinery, doors and painting are however quite good and the floor tiling and tiling to toilets is good. The external veranda wall to the main building and the walls to the classroom have been painted with very nice Disney murals. The septic tank is 16 metres downhill from the well and is just about acceptable.
