Multi-Purpose Buildings for Disaster Situations in Thailand

Report prepared by
Mr. Kriangsak Charanyanond, Architect

To cope with disaster situations caused by frequent floods and strong winds in the south of Thailand, a Task Force within the Thailand Department of General Education has analyzed the threats, developed maintenance procedures and proposed a prototype multi-purpose building for primary and secondary schools. They have recommended the construction of this building as a pilot project that will be analyzed and evaluated prior to its replication nationwide.

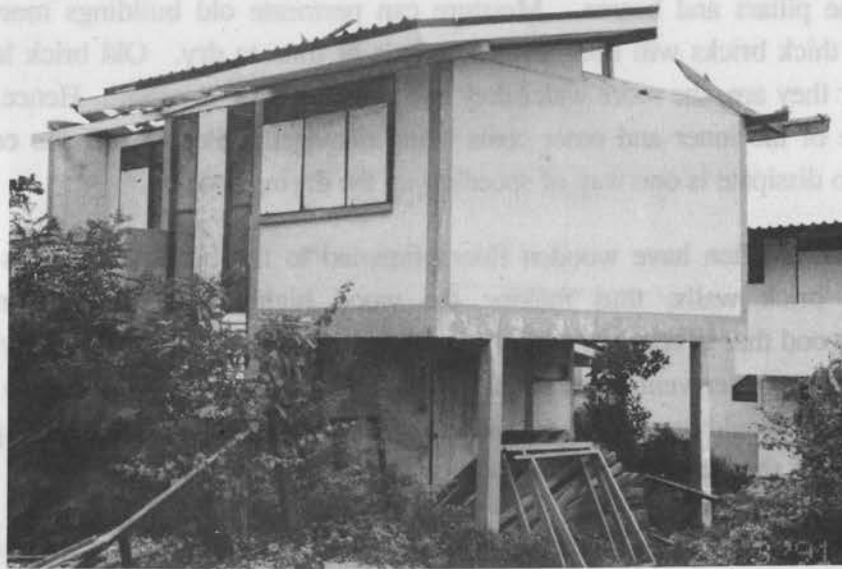
Buildings damaged by flood and wind

Flood water that is a mix of fresh and sea water poses greater damage to building materials due to the salt components of sea water. Sea water takes longer to dry up than fresh water because of its water-holding property. It can cause more damage to metals and electric wires. Buildings in the south are not designed to withstand adverse factors in coastal areas. The concrete used is not mixed with anti-sulphate substance. Since sea water is more damaging, more thorough inspection should be carried out than in the case of normal flooding. Sulphate from the sea will soften the brick surface and cause it to chip off. If the bricks are submerged for several days, sulphate from the sea will erode the surface and cause it to peel off. This is also true for concrete blocks that have not been coated with anti-sulphate substance. When they are subjected to chemical reaction from the sea water for a long period of time, their surface will be affected and cracks may form.

The effect on the outer coating of a building that has been submerged in sea water for several days is quite pronounced. Cracks or chips due to erosion by sulphate salt from the sea weakens the adhesive property of the coating, in proportion to the amount of moisture from the sea permeating the surface of the brick wall.

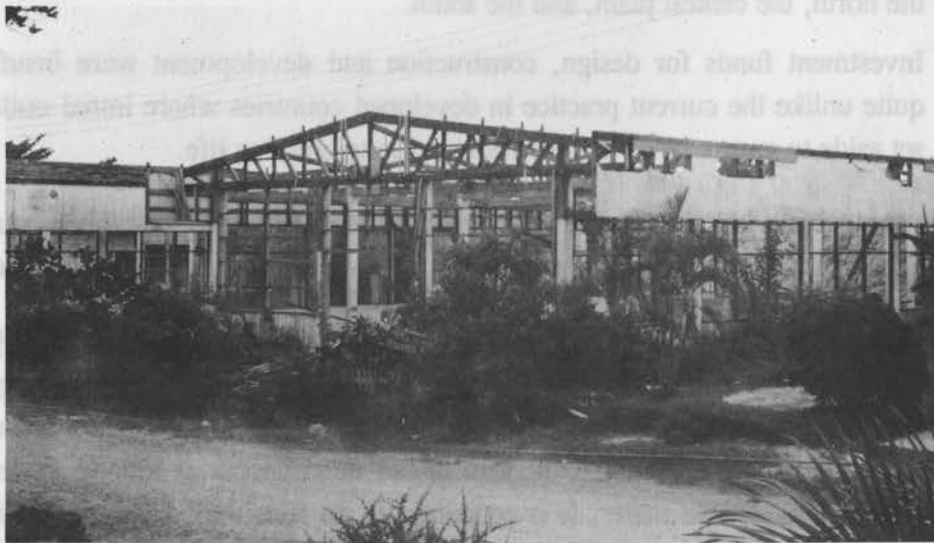
Buildings damaged by Typhoon Gay on 3 November 1989

Wooden buildings of a conventional/standard design are more susceptible to damage than modern buildings utilizing a reinforced concrete structure. As it happened, Typhoon Gay seriously damaged wooden school buildings, completely destroying the upper sections. Only the pillars and beams were left standing. In contrast, buildings with reinforced concrete pillars and beams retained all the concrete parts, including the floors and certain roof structures. As for new-generation buildings constructed on foundations made entirely of reinforced concrete, only the rooves, doors and windows were blown away. All the brick walls were left intact.
